## Regular Council Meeting

| <b>Report Number:</b> | Parks and Facilities 2024-05 |
| <b>Subject:</b> | Mould Assessment Results and Required Remediation at Millbrook Arena |

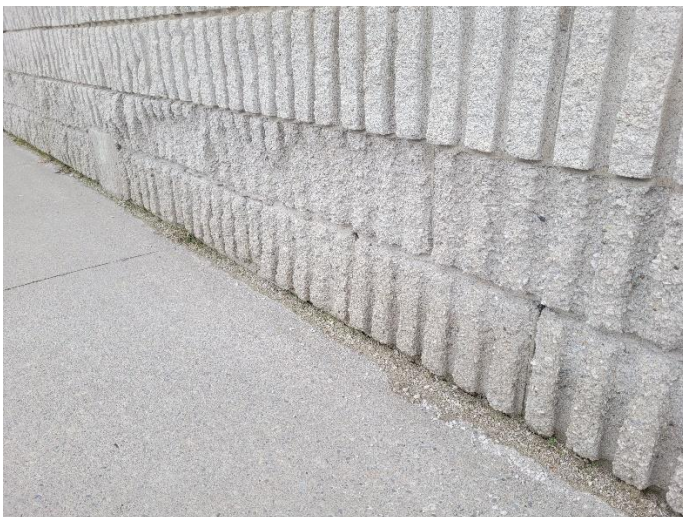
Photo 22 – Damaged Split Ribbed Block at Southeast Corner

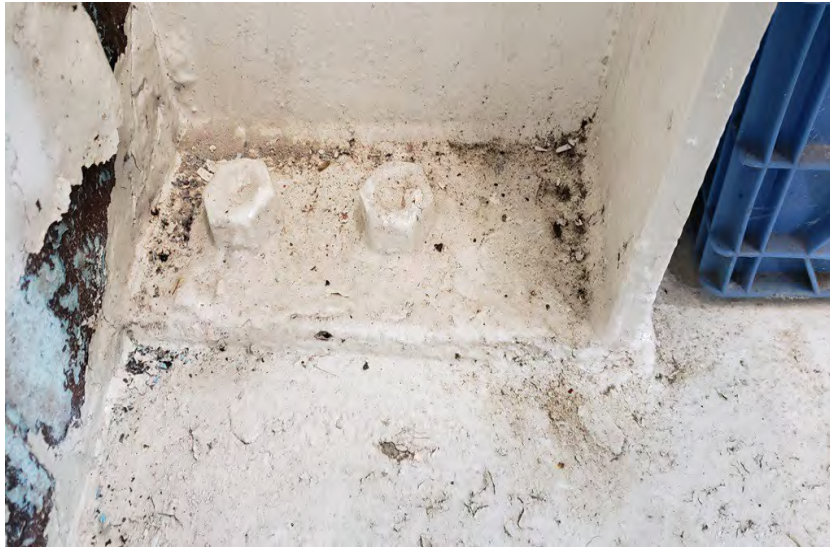
Photo 006      Rusted Bracing Connection

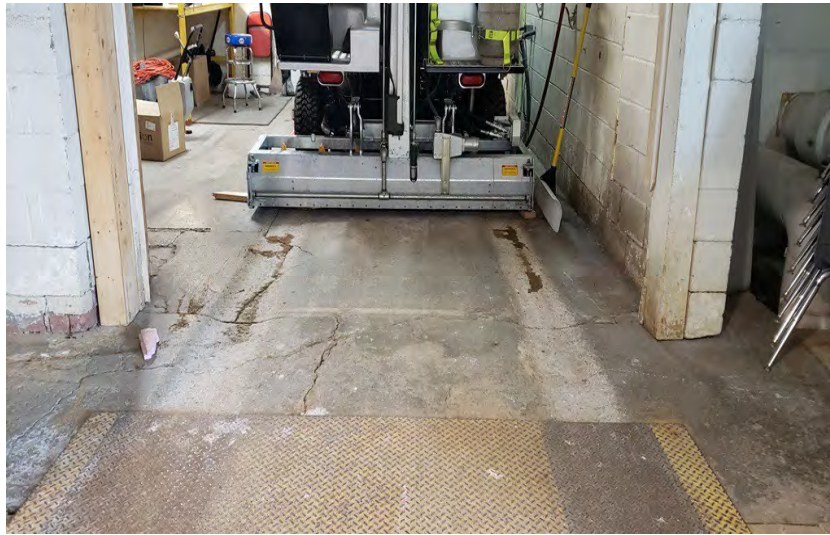
Photo 019      Major Crack in Apron Slab

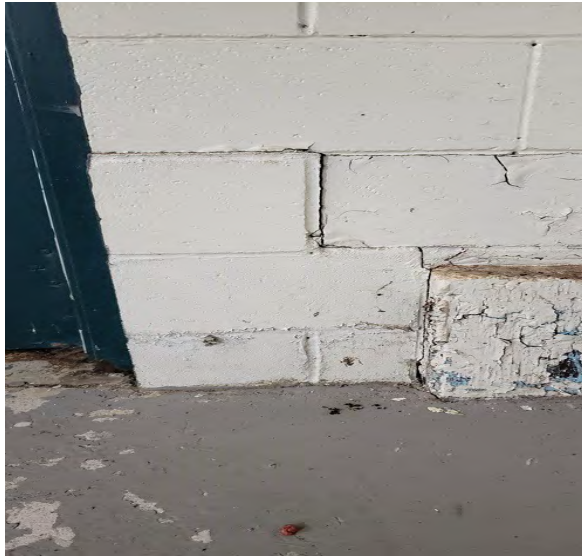
Photo 038 Block and Joint Damage

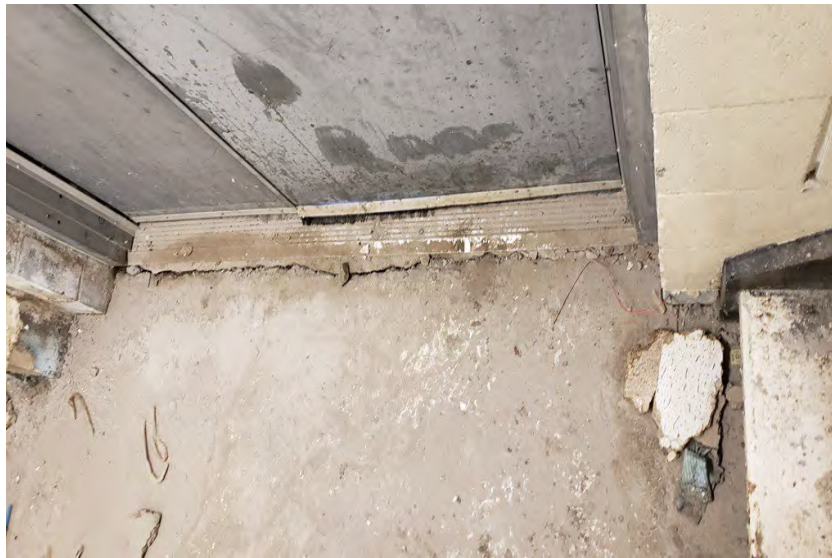
Photo 053      Concrete Damage at Electrical Equipment in  
Compressor Room

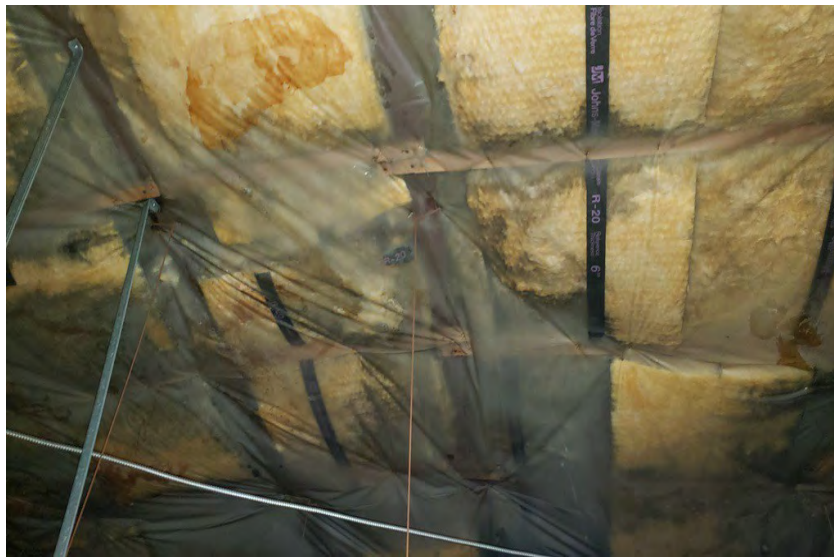
Photo 059      Moisture in Roofing System

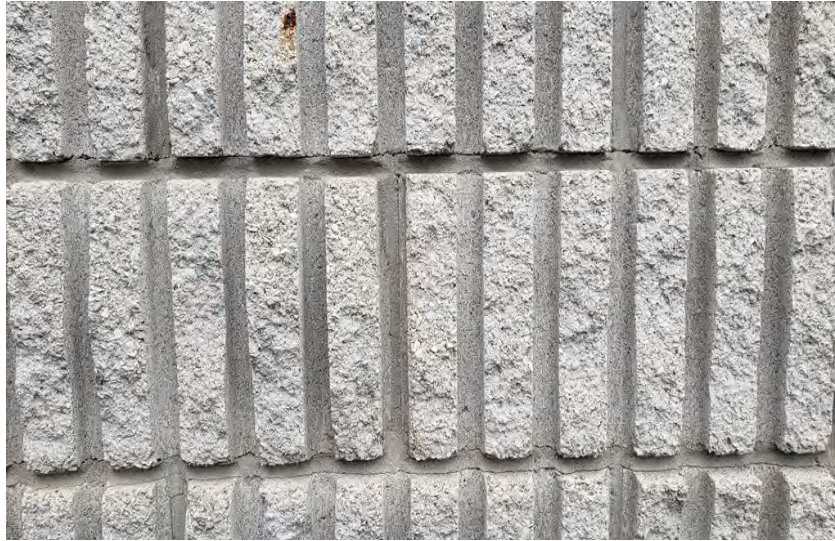
Photo 064      Cracking at Centre Foundation Wall

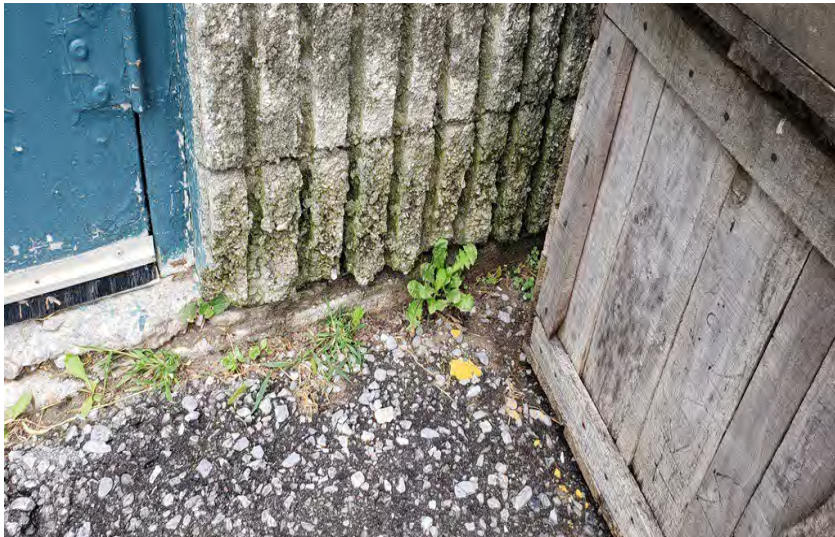
Photo 073      Moss Along East Side Wall

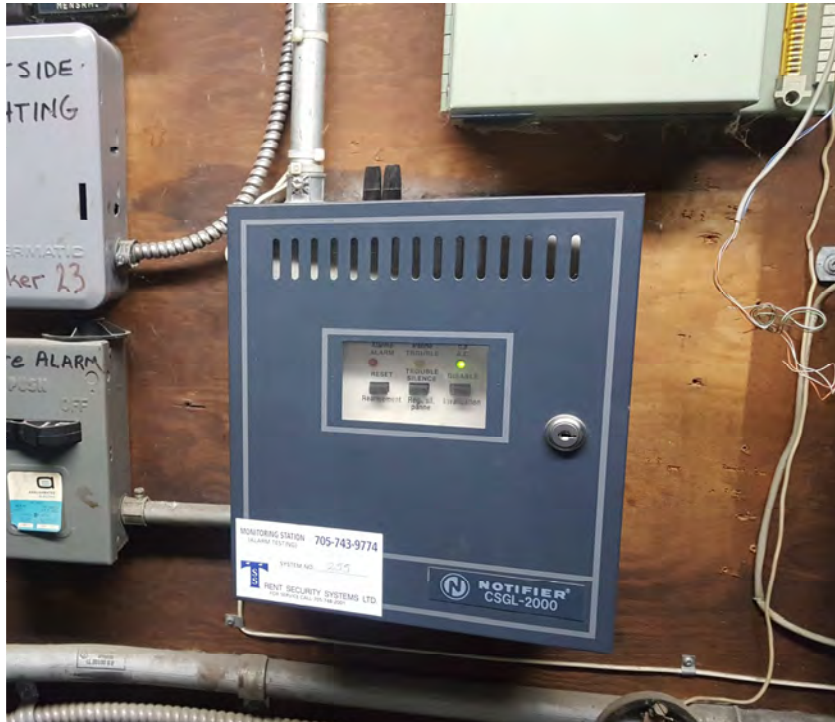
- 6.1 The existing fire alarm system is a single zone Notifier CSGL-2000. While it appears to be in good working order it is outdated and should be considered for upgrade.

- 6.2 The fire alarm devices appear to be original and should be considered for replacement.
- 6.3 The notification devices are bells. Consider adding strobe coverage for improved notification.

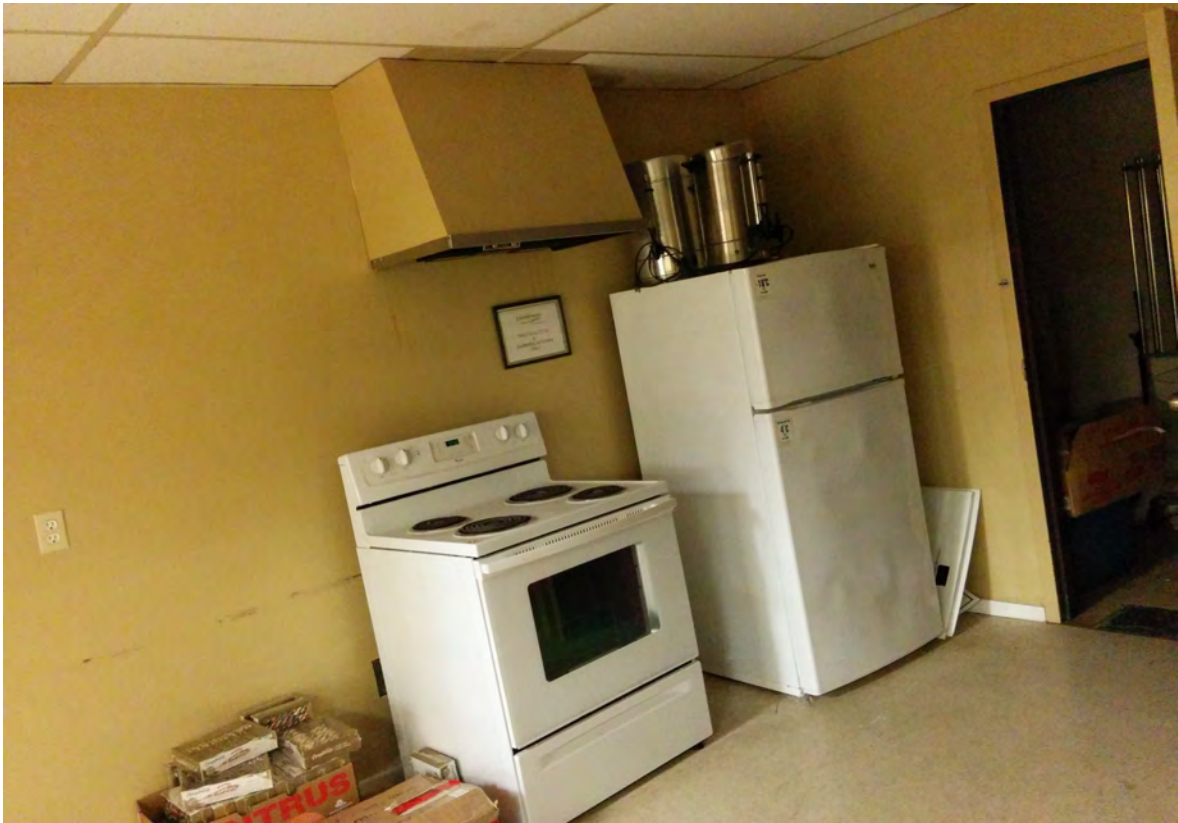
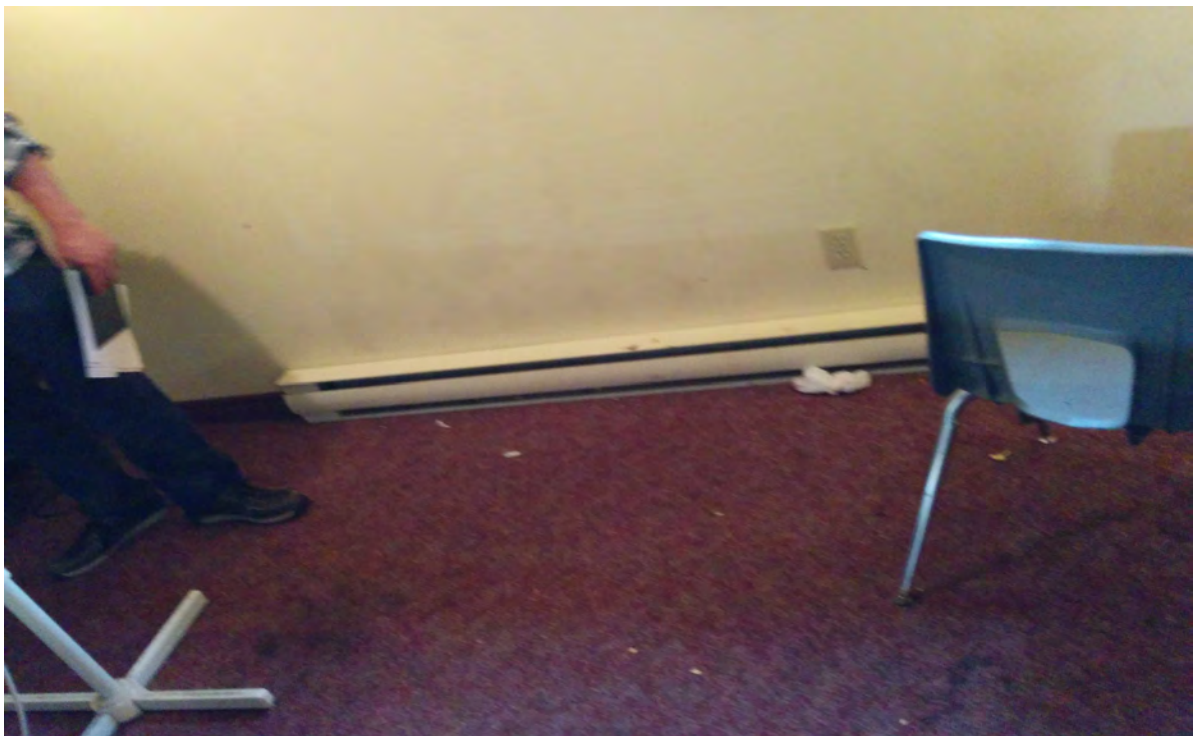
- 5.1** The exhaust air systems from washrooms, change rooms were not provided with exhaust fans or ducts as required by codes.
- 5.2** There is no heat recovery system for ventilation in the mechanical room.
- 5.3** The building roof is in bad condition with many leaks so that the mechanical system cannot work efficiently.
- 5.4** The range hood for the stove is not installed as required by codes and standards.
- 5.5** The Second-Floor room was heated with a base board electrical heater without any ventilation or exhaust fan.
- 5.6** The building has no fire suppression system.
- 5.7** The building has no automated control system for the mechanical or electrical system.
- 5.8** There are many spaces in the building that have no heating, cooling or ventilation.
- 5.9** No water treatment for the water in the mechanical room.
