September 6, 2019
Project: 6461

Electrical Site Condition Assessment Report

Project: **Millbrook Arena**
4 Needler's Lane
Millbrook, ON
L0A 1G0

Review Date: Tuesday August 27th, 2019 at 2:00 pm
Reviewed by: David Millen, P.Eng. Electrical

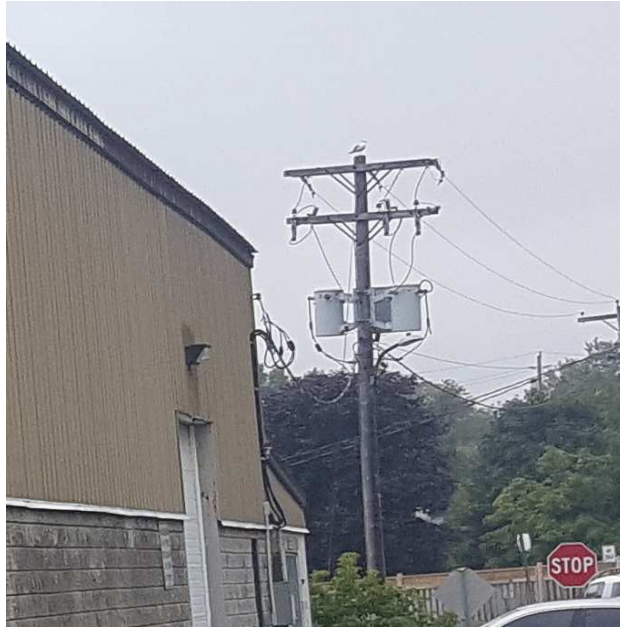
- 2.1 The facility is powered by two separate utility services. The 120/240V 200A service that supplies the front of the building (Front Service) and the 600V/347V 400A service that supplies the rear of the building and ice plant (Rear Service).
- 2.2 A set of three pole mounted 75kVA pole mounted transformers supply the Rear Service used primarily for the ice plant. The transformers are configured as a solidly grounded 4 wire 347/600V supply at 225kVA.
 - 2.2.1 The transformers and pole assembly appear in decent condition.
 - 2.2.2 The secondary conductors run overhead individually from the service pole to the arena wall where they transition to core flex and run down the exterior wall and into the rear electrical area and the 600V main disconnect.

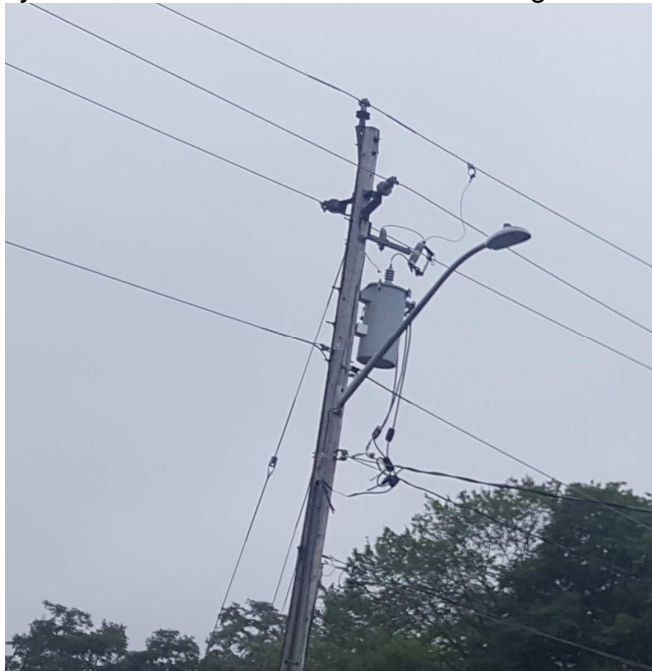
2.3.1 The transformer appears in good condition. The transformer also supplies the street lighting to the west.

2.3.2 The secondary conductors run overhead individually from the service pole to a wall mounted cable termination rack. The cables enter a raceway via a weather-head and drop to the utility meter on the exterior of the building.

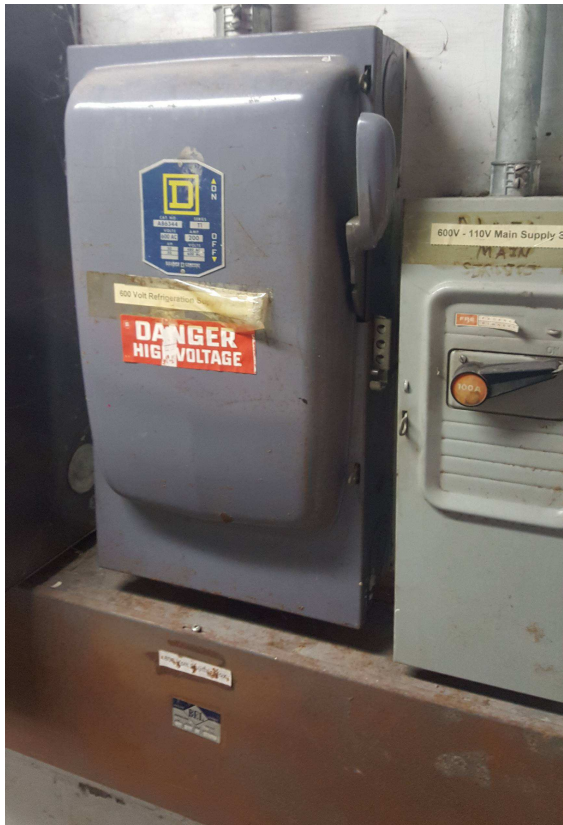
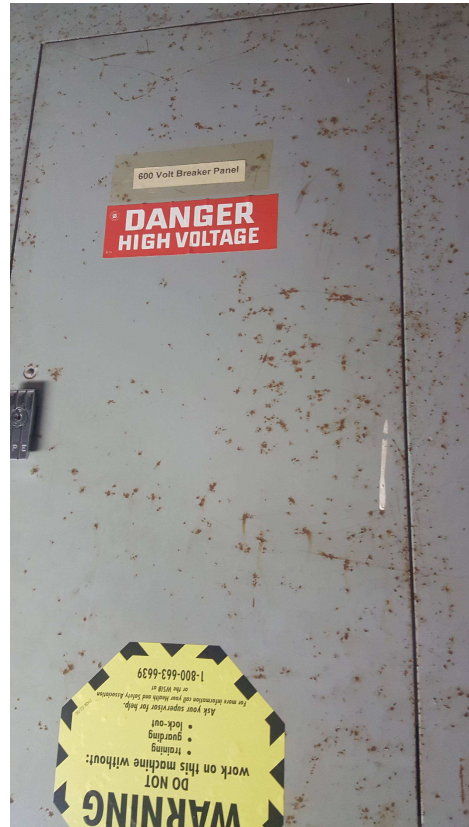
- 3.8 The Panel board, a federal pioneer NHDP 225A 3 phase 4 pole model, supplies the ice surface lighting, de-humidifiers and exhaust fans.
- 3.9 The 600V equipment appears to be all original and is all very dated with signs of many years of wear. The splitter is completely covered in rust caused by the high humidity in the area where the equipment is installed.

- 3.10 A 100A 120/240V panel is installed at the rear of the facility that is supplied from the Front Service for exit lights, lighting, receptacles, small fans and the timeclock.
- 3.11 It is recommended to conduct an inspection and preventative maintenance of the interior.

- 7.3 In the long term (> 5 years) some changes should be done to improve maintenance costs and efficiency. The following values are rough estimates and do not account for any other changes required by structural and mechanical divisions or any change of use for the facility.
- 7.3.1 Replace 600V splitter: \$1200.00
- 7.3.2 Replace linear fluorescent fixtures with LED fixtures
 - Replace Metal Halide with High Bay LED
 - Replace lighting controls (add occupancy control, dimmers etc.):
 - Replace emergency lights with LED and Exits with Running Man LED: \$90,000
- 7.4 The existing fire alarm system is adequate but doesn't provide visual notification (strobes).
- 7.4.1 Replace fire alarm system: \$60,000

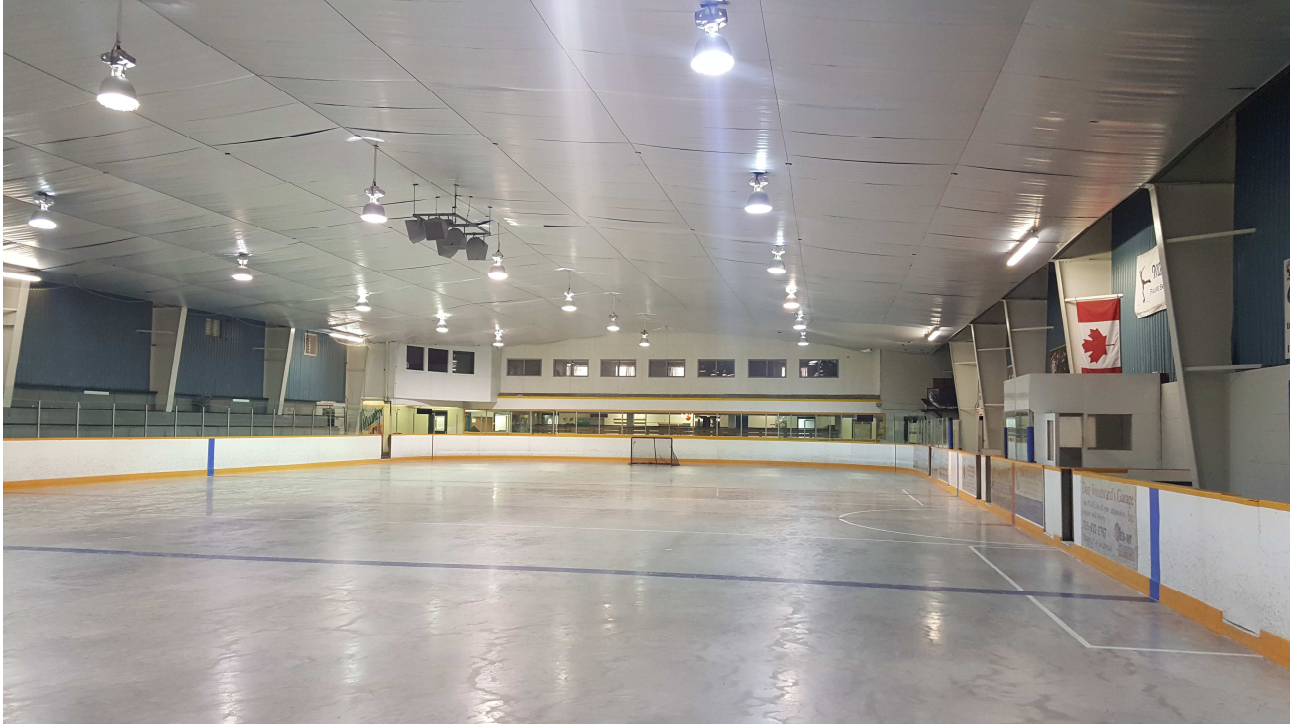
5.1 The ice surface lighting is 400W 347V Metal halide.

5.2 It is recommended to replace the existing metal halide fixtures with LED for improved control, instant on capability and longevity.

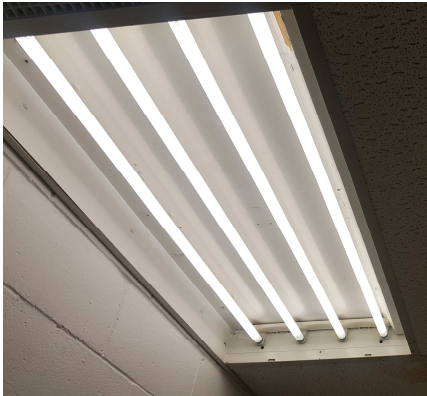
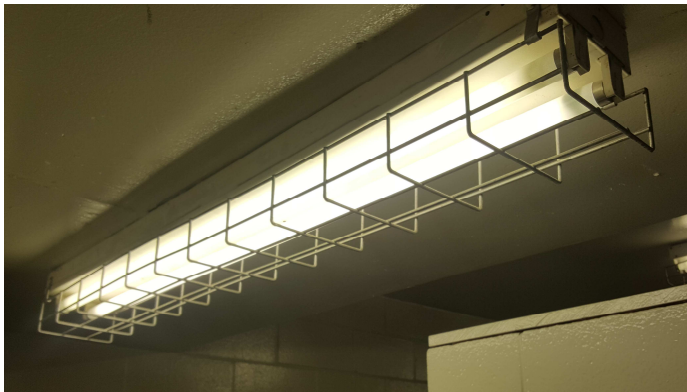
5.3 Most of the existing 120V lighting fixtures are tubular fluorescent fixtures. Some incandescent fixtures have been upgraded to CFL lamps.

5.4 It is recommended to replace the existing fluorescent fixtures with LED, not just replace the lamps with LED equivalents.

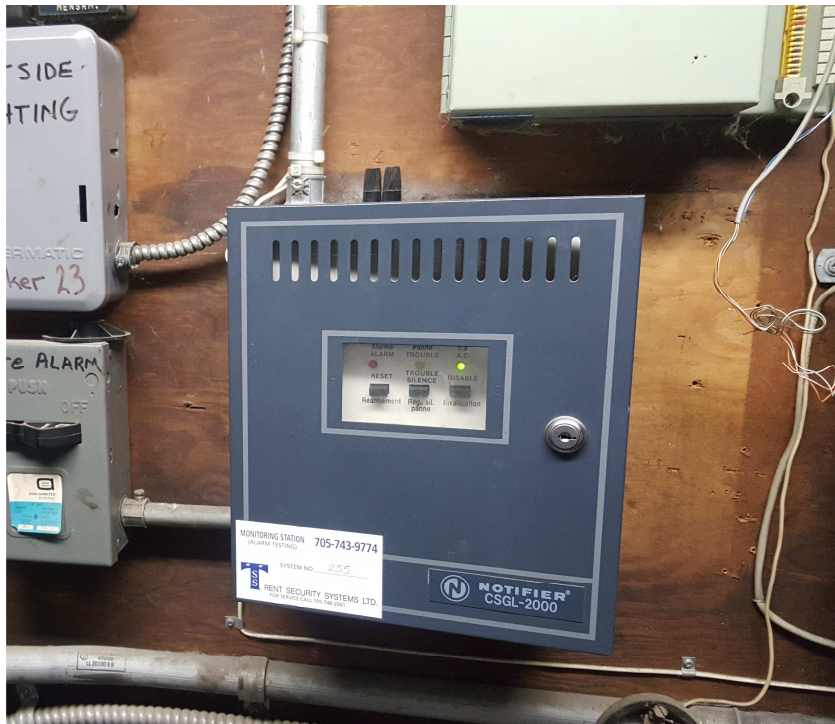
- 6.1 The existing fire alarm system is a single zone Notifier CSGL-2000. While it appears to be in good working order it is outdated and should be considered for upgrade.

- 6.2 The fire alarm devices appear to be original and should be considered for replacement.
- 6.3 The notification devices are bells. Consider adding strobe coverage for improved notification.
