Mechanical Site Condition Assessment Report

Project: **Millbrook Arena**
4 Needler's Lane
Millbrook, ON
L0A 1G0

Review Date: Tuesday August 27th, 2019 at 2:00 pm

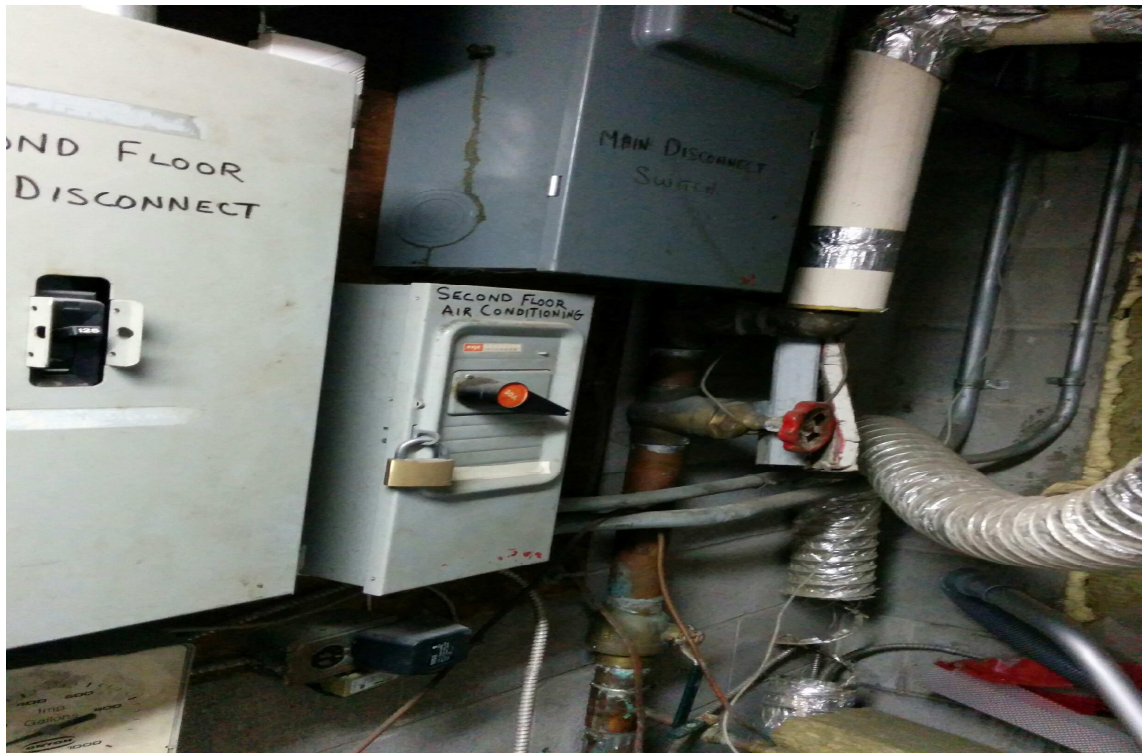
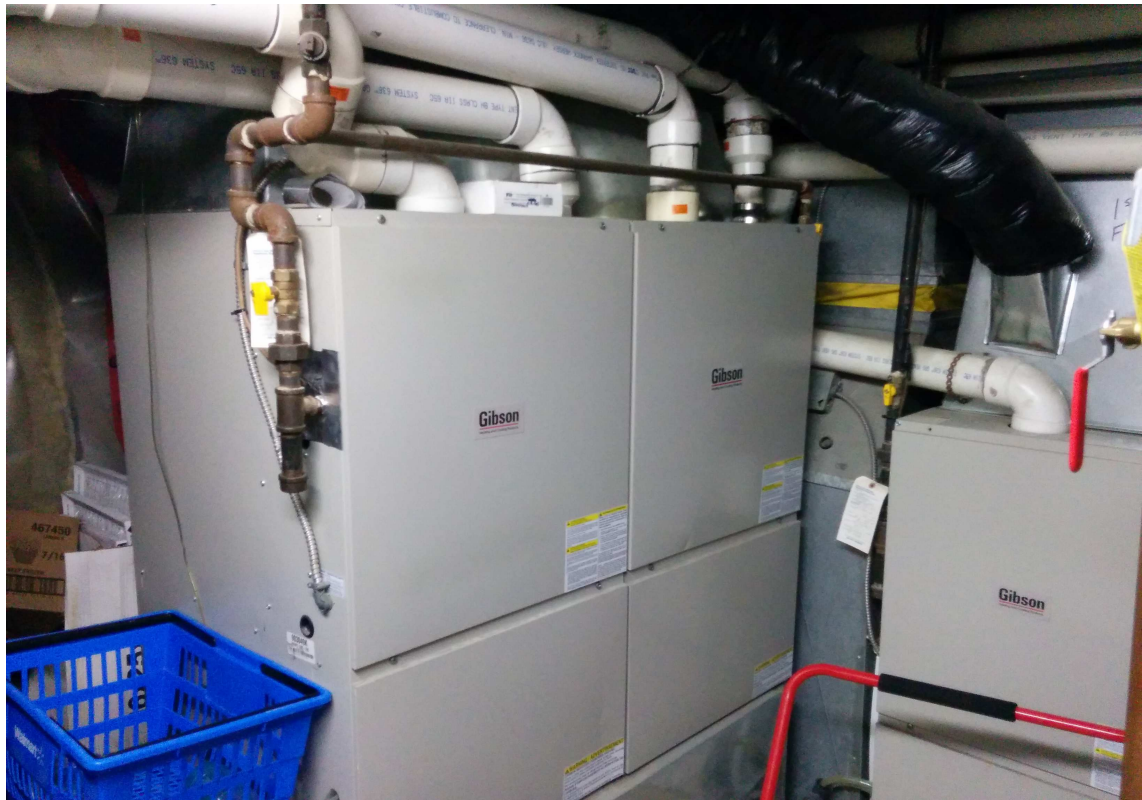
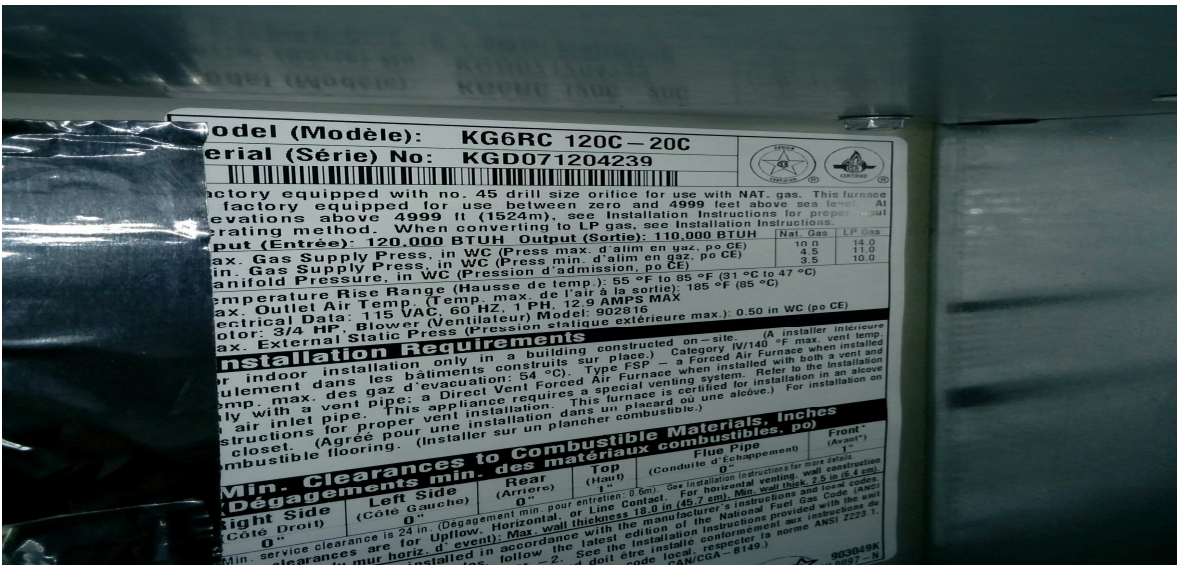
- 2.1 The building has four Gibson furnaces for heating only, each has a capacity of 110,000 Btu/hour with efficiency of more than 90%, natural gas fueled.
- 2.2 The building has no cooling as there is no direct expansion coils above the furnaces and a roof top unit could not be verified on the roof.
- 2.3 The building has no ventilation, no heat recovery or energy recovery units, no ventilation ducts and no exhaust duct from the ducting system.
- 2.4 There are no heating, cooling or ventilation calculations to verify if the furnaces are covering the heating load or the cooling capacity required and ventilation or outside fresh air required for the whole building.
- 2.5 The mechanical room is cramped, cluttered and very small for all the equipment in it.

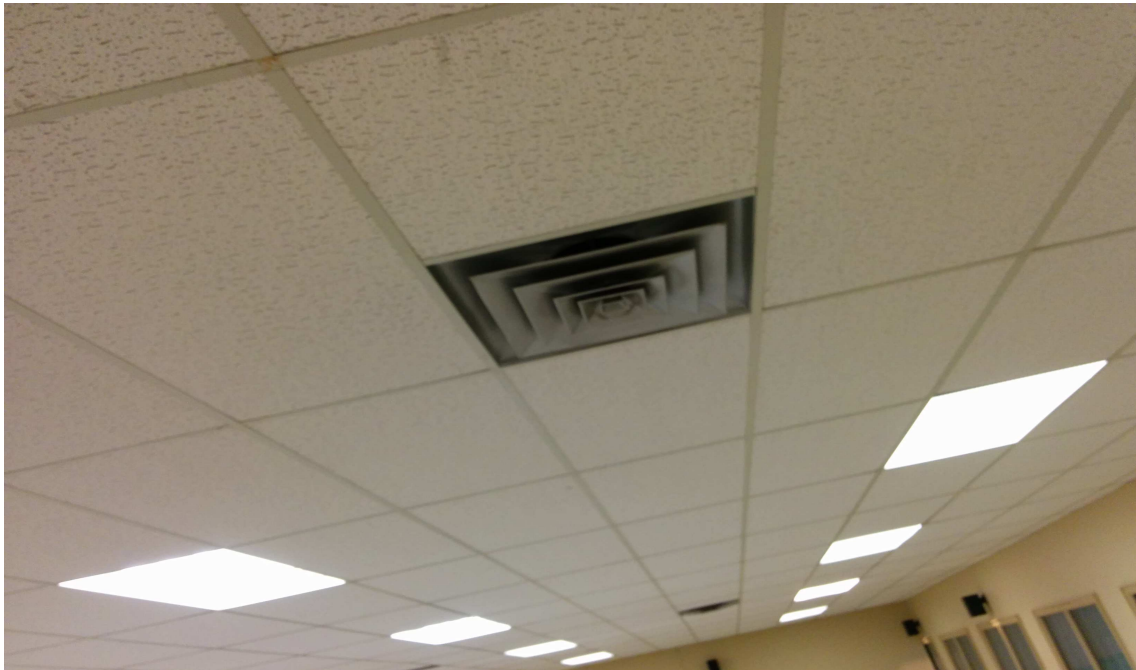
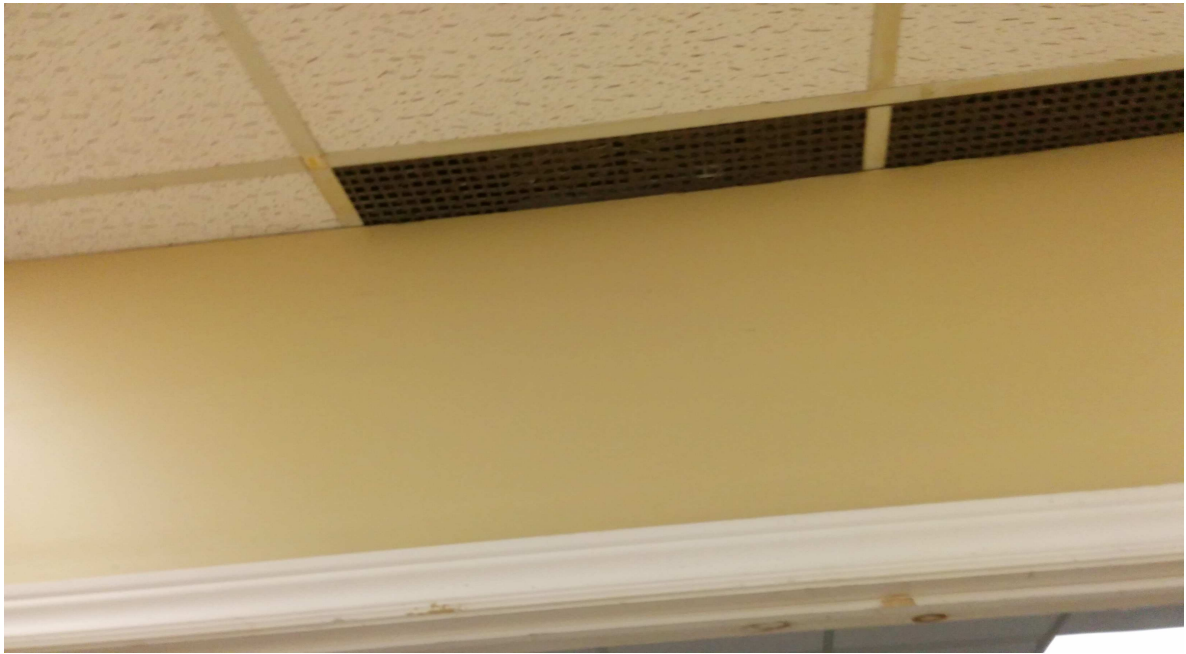
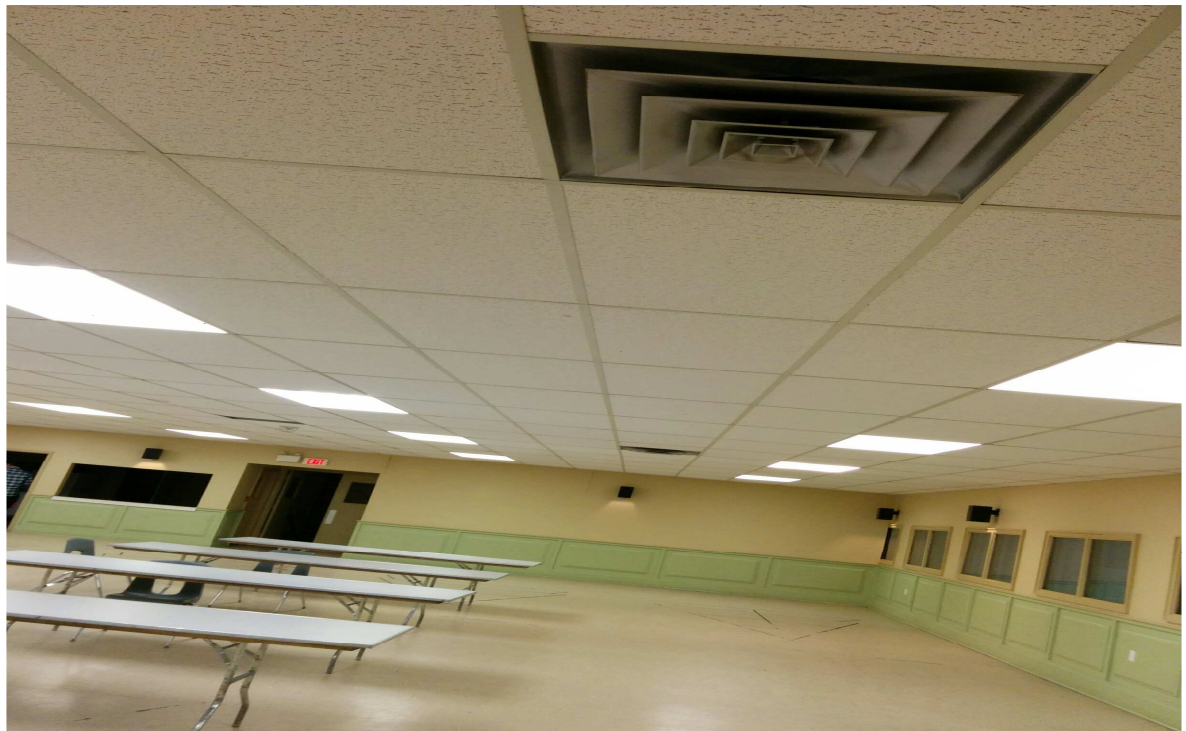
- 2.6 The ducting system had no access panels to verify if there are balancing dampers or any other dampers. The ducting was not accessible to verify how the fittings were done or if they were insulated.
- 2.7 The diffusers are in bad condition; there is very poor air and temperature distribution in the second floor. The diffusers were separated from each other by a long distance without return grills in the same space.

- 6.2 Most of the grills need to be replaced and some are missing so they need to be added
- 6.3 Ventilation and fresh air should added to both floors with HREVs which will need additional ducting and connections to the existing duct system.
- 6.4 The second floor washroom should be returned to a operational state.
- 6.5 Exhaust fans should be installed for the change rooms
- 6.6 Additional diffusors should be added in the corridor of the first floor.
- 6.7 These works with equipment estimated to cost around \$100,000.00

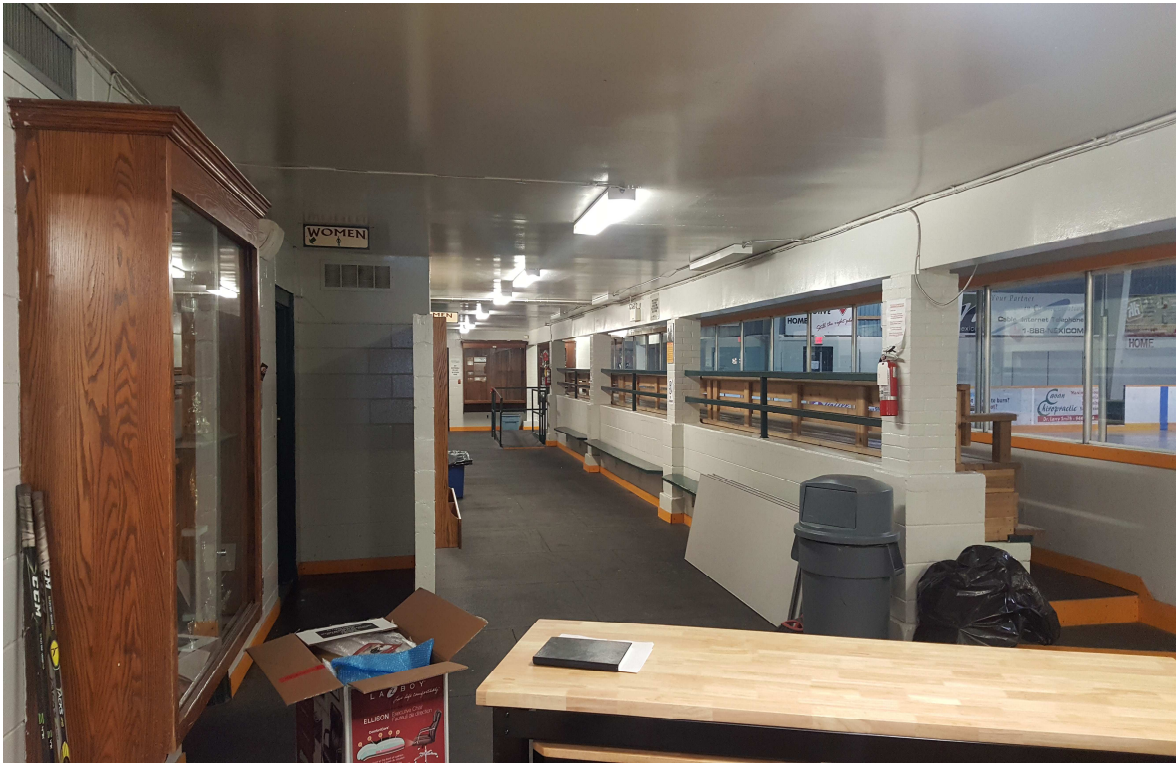
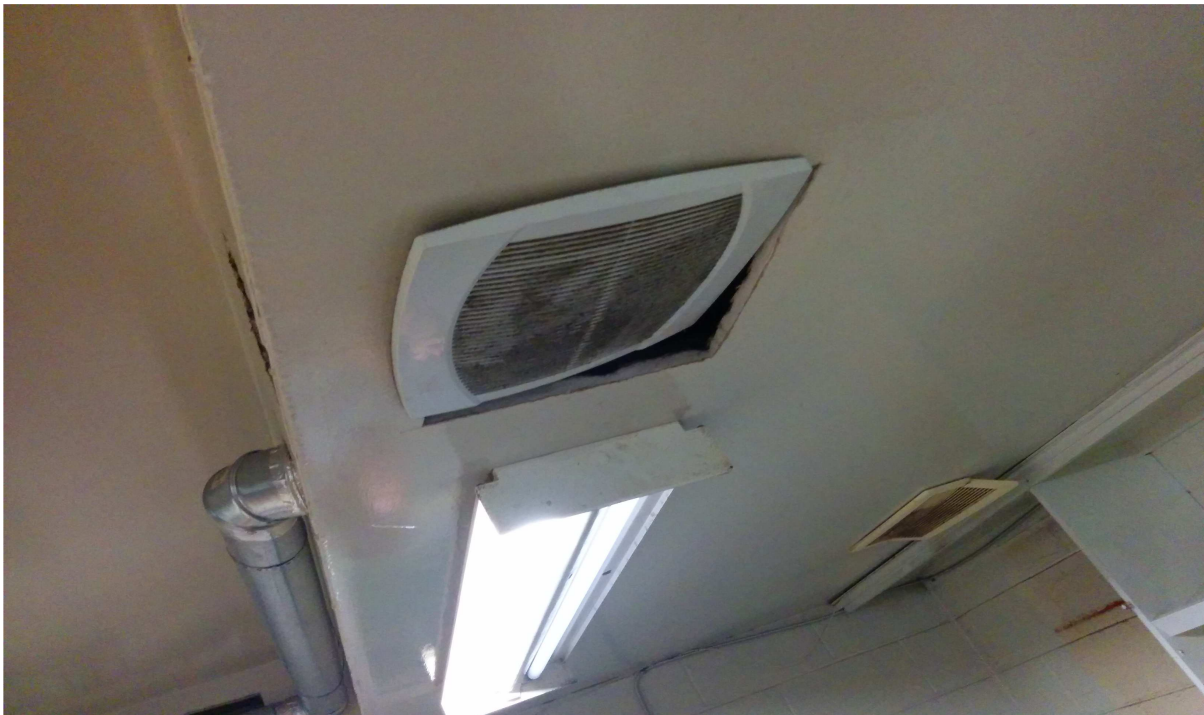
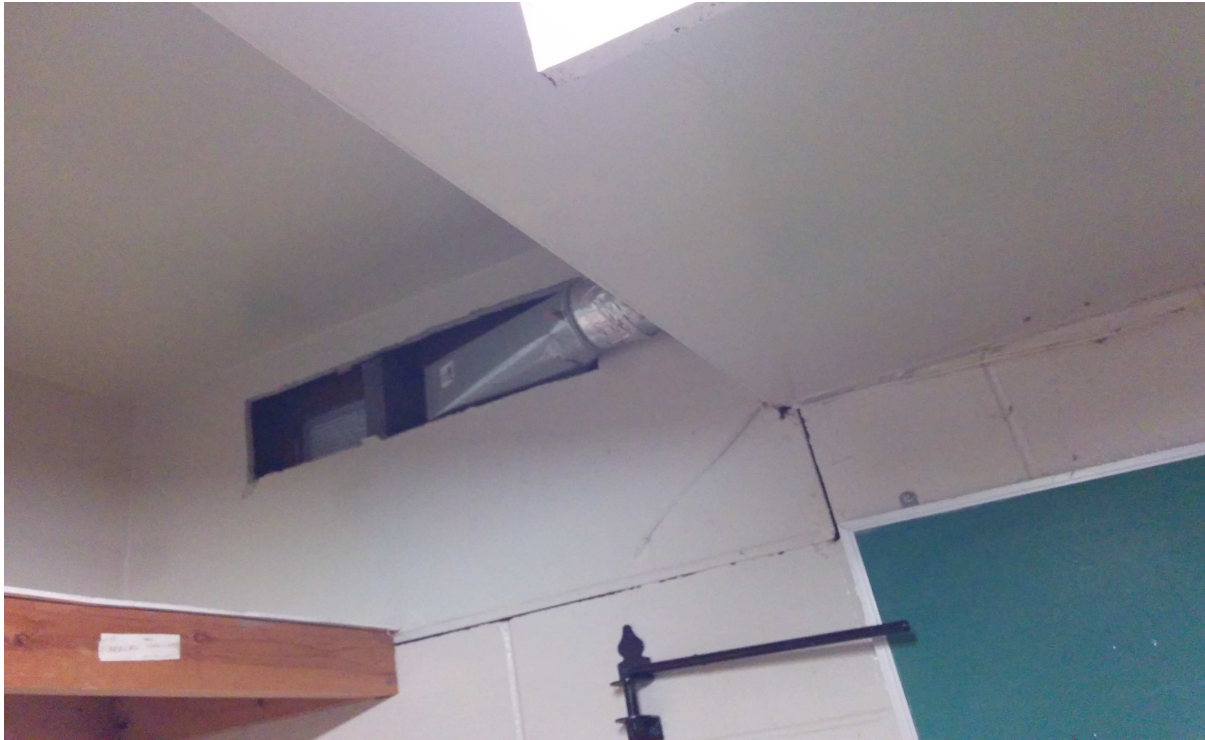
- 2.8 The supply diffusers were in a space and the return grills were in a different space.
- 2.9 Some other spaces had no supply diffusers nor return grills.
- 2.10 There is no heating, ventilation and cooling in the rink lobby as required by codes and standards. The whole corridor in the first floor had no diffusers or grills, which means no heating, cooling or ventilation.

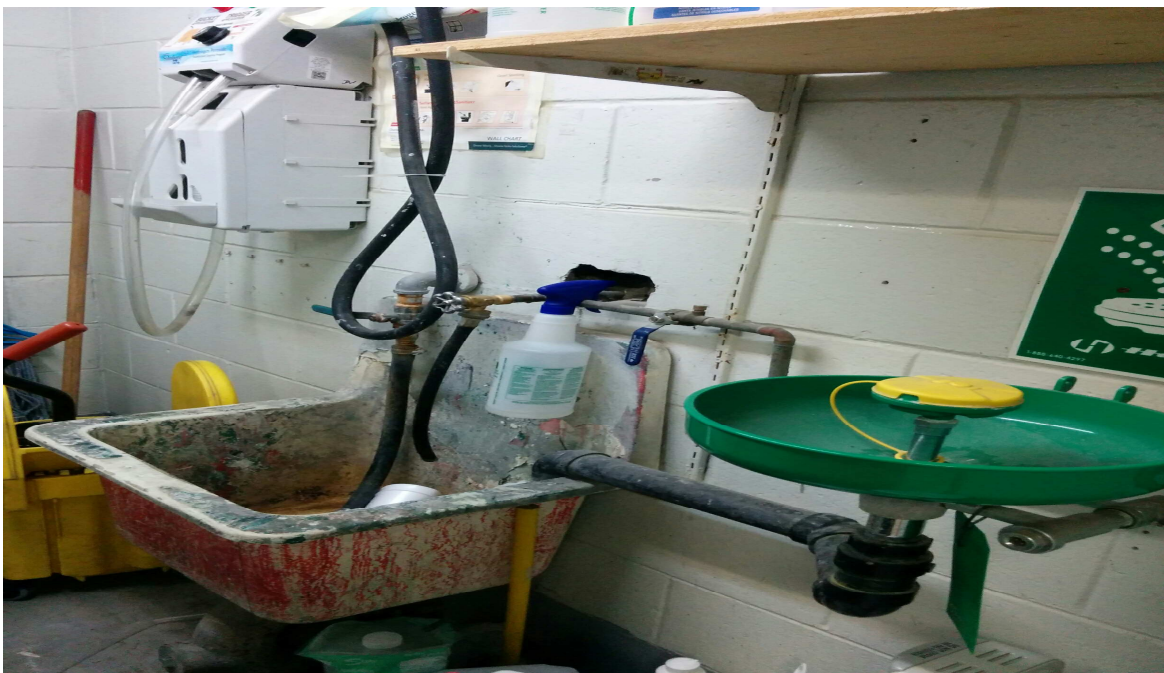
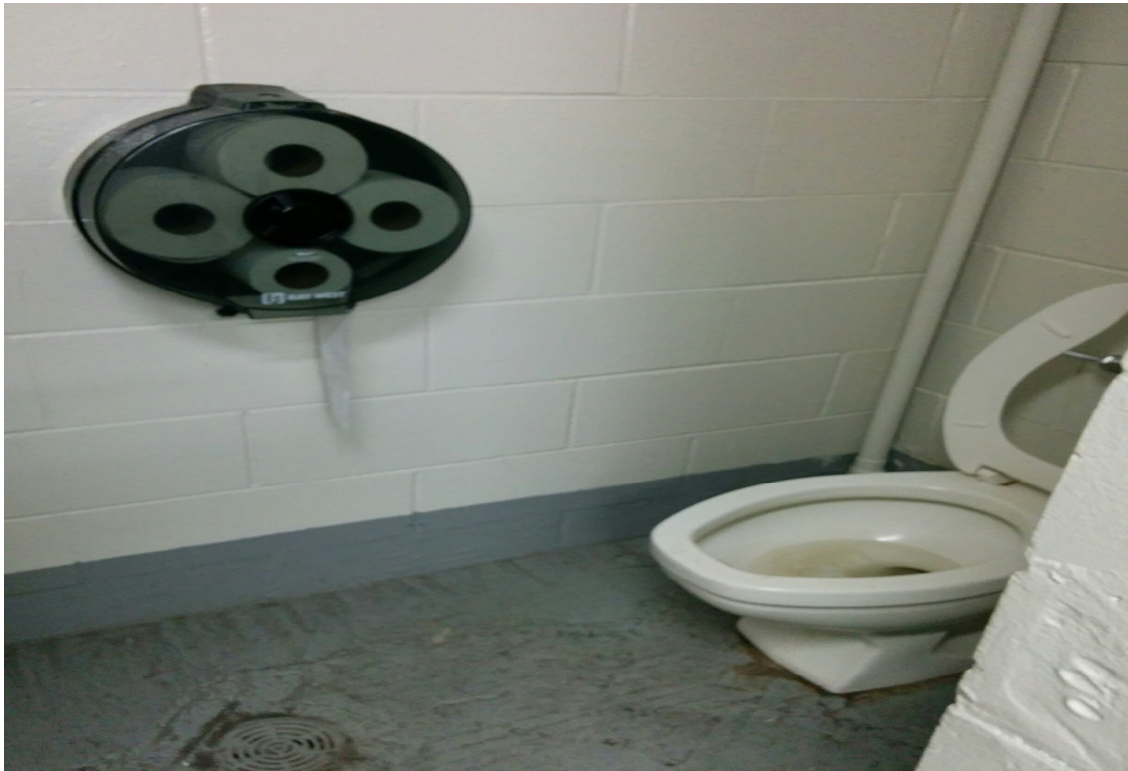
3.1 The fixtures as shown in the photos are in bad conditions and old.

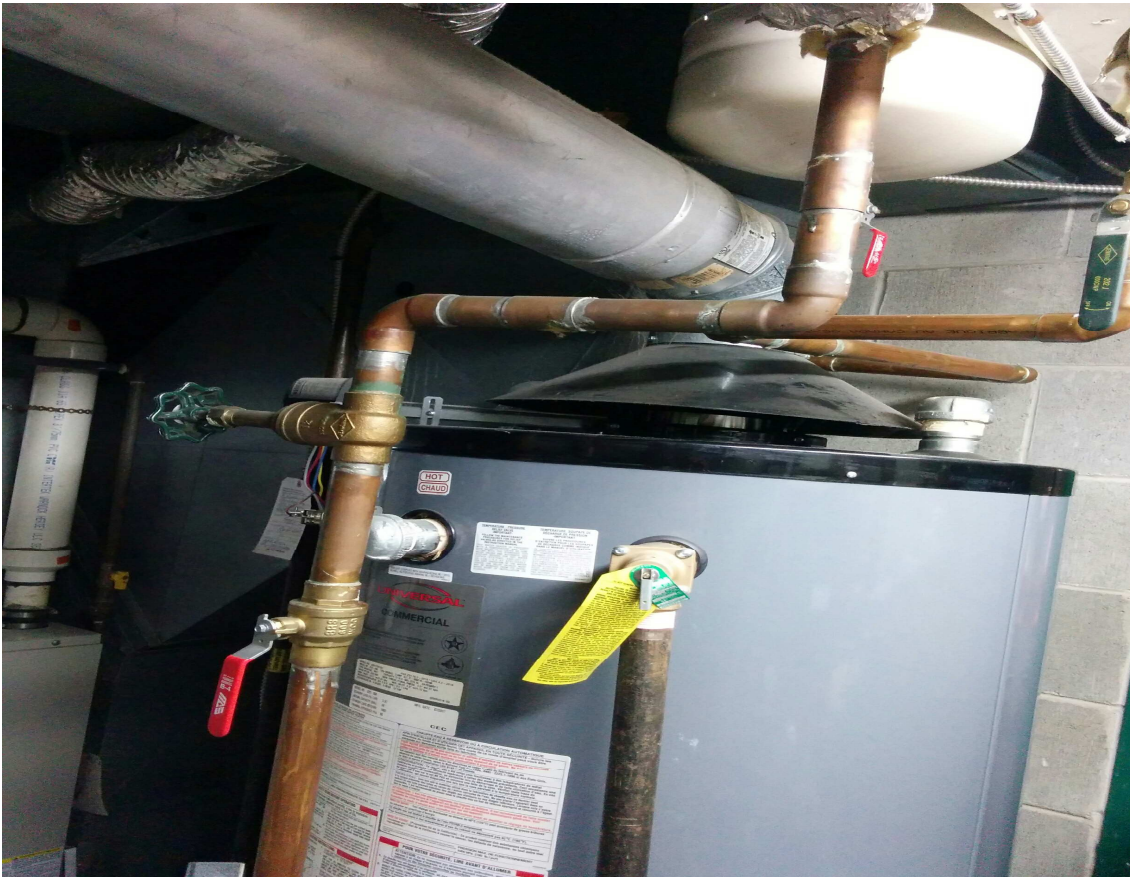
- 4.1 The fixtures are old, low efficiency and at the end of their life.
- 4.2 The pipe system could not be verified as most of it were in the ceiling space or inside walls.
- 4.3 The hot water tank is a good condition and the pipes inside the mechanical room are copper and in a good condition.
- 4.4 The incoming main domestic water pipe, valves and the meter are old, no back-flow meter was noticed.
- 4.5 No insulation on hot water pipes noticed in the whole building except some pipes in the mechanical room.
- 4.6 There was an expansion tank installed above the hot water tank.
- 4.7 No ventilation in the mechanical room and no recirculating pump.
- 4.8 No clearances around all equipment.

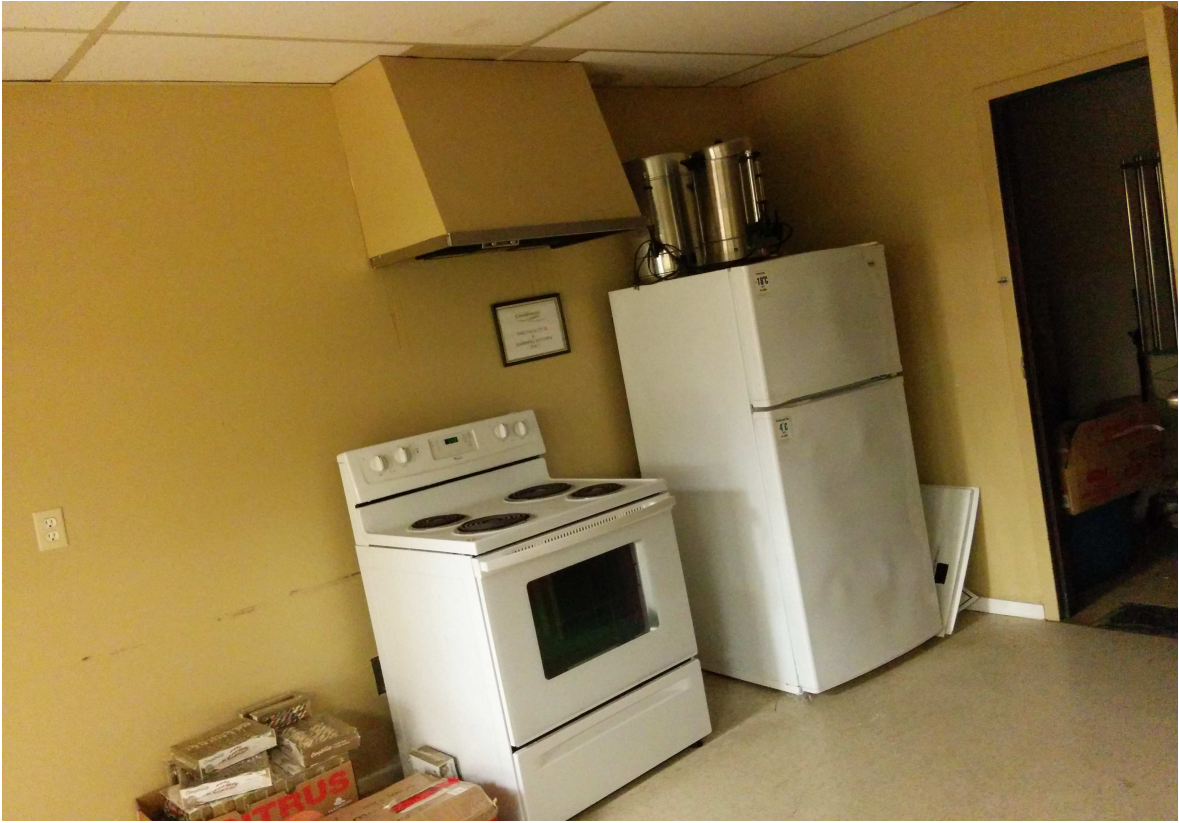
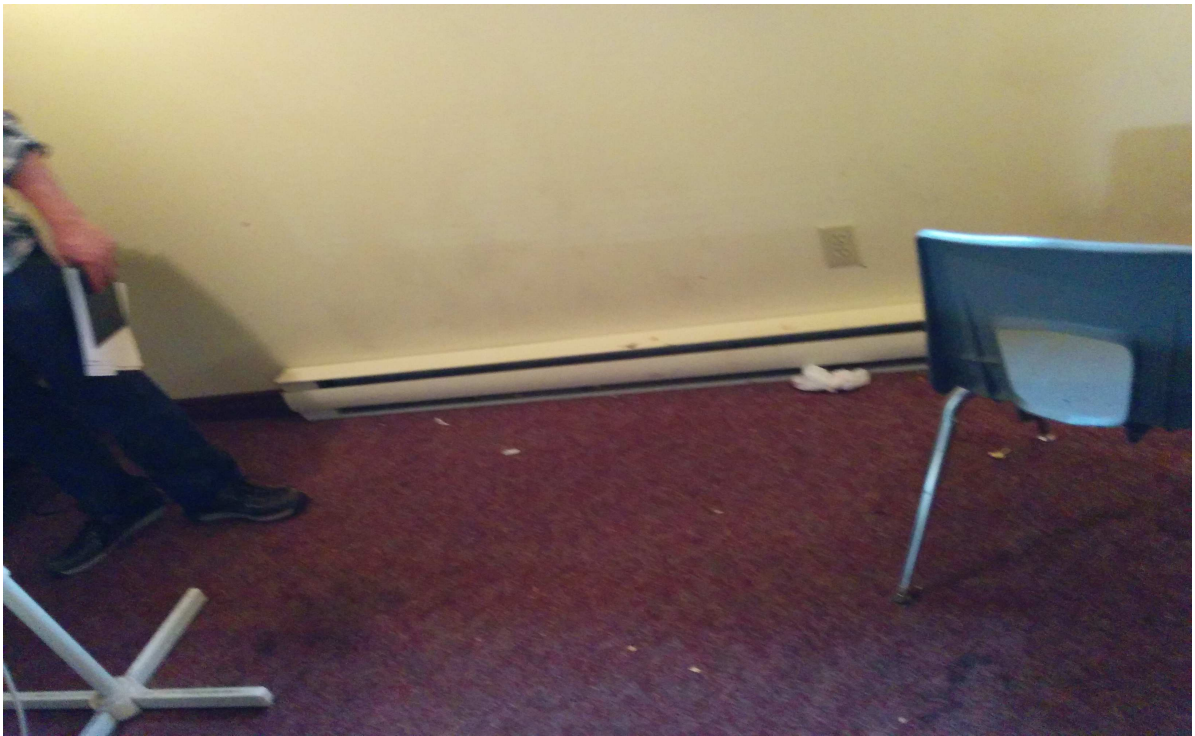
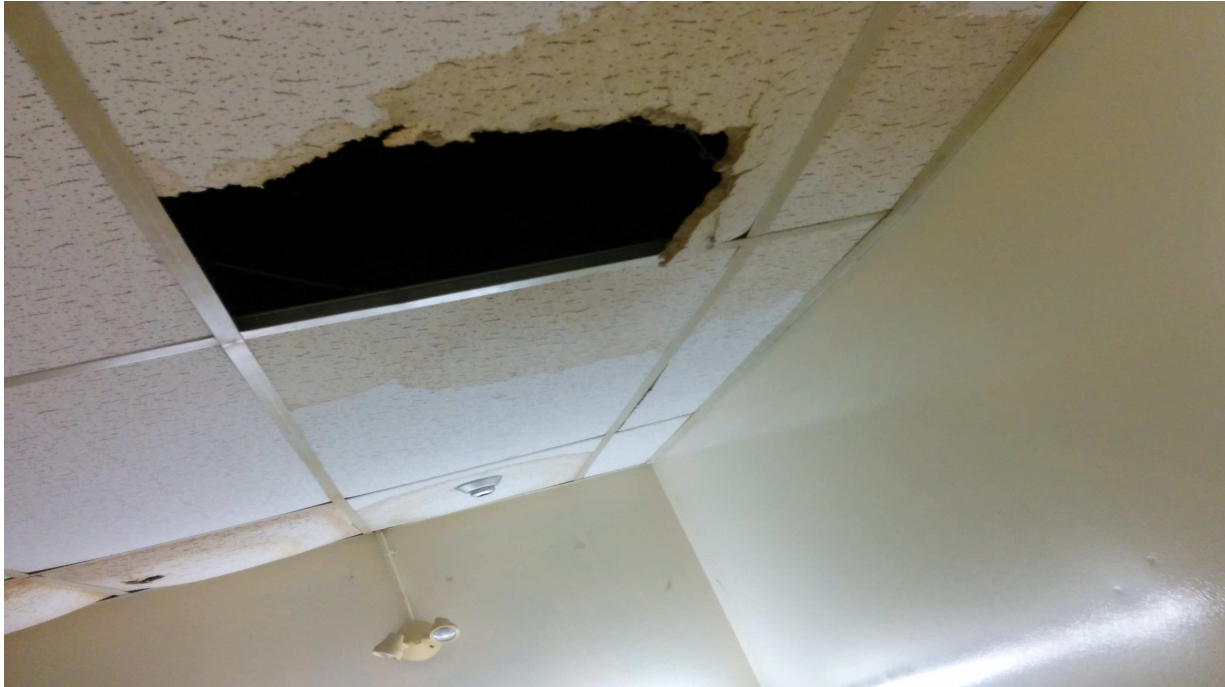
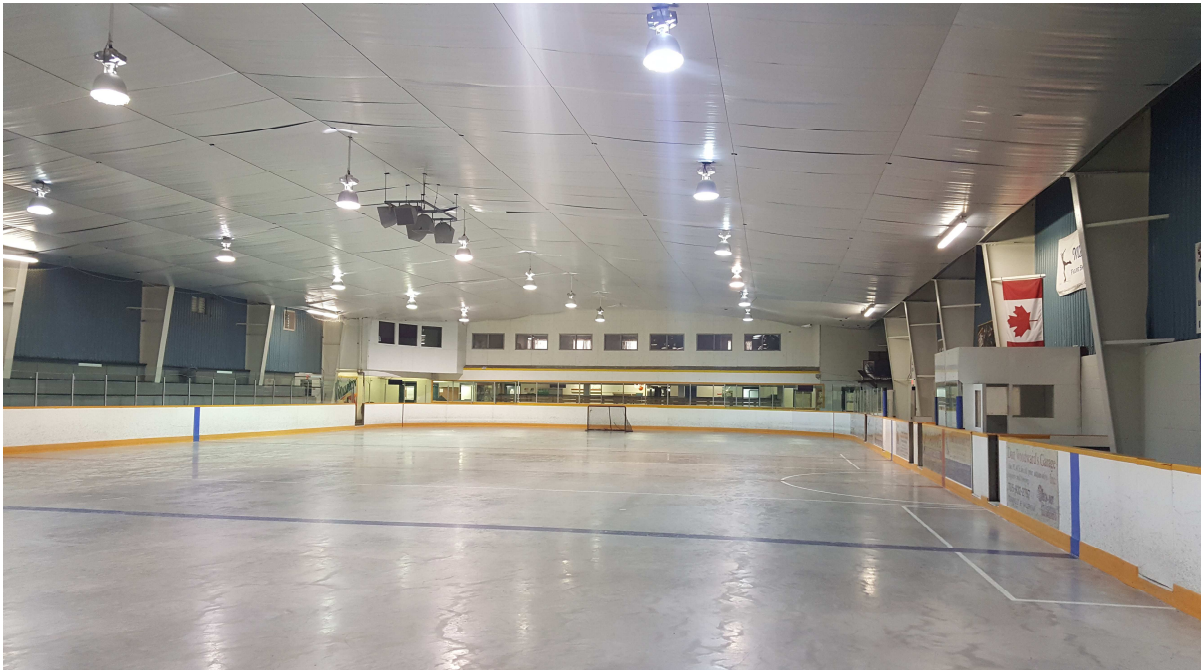
- 5.1 The exhaust air systems from washrooms, change rooms were not provided with exhaust fans or ducts as required by codes.
- 5.2 There is no heat recovery system for ventilation in the mechanical room.
- 5.3 The building roof is in bad condition with many leaks so that the mechanical system cannot work efficiently.
- 5.4 The range hood for the stove is not installed as required by codes and standards.
- 5.5 The Second-Floor room was heated with a base board electrical heater without any ventilation or exhaust fan.
- 5.6 The building has no fire suppression system.
- 5.7 The building has no automated control system for the mechanical or electrical system.
- 5.8 There are many spaces in the building that have no heating, cooling or ventilation.
- 5.9 No water treatment for the water in the mechanical room.
