## Regular Council Meeting

| <b>Report Number:</b> | Parks and Facilities 2024-05 |
| <b>Subject:</b> | Mould Assessment Results and Required Remediation at Millbrook Arena |

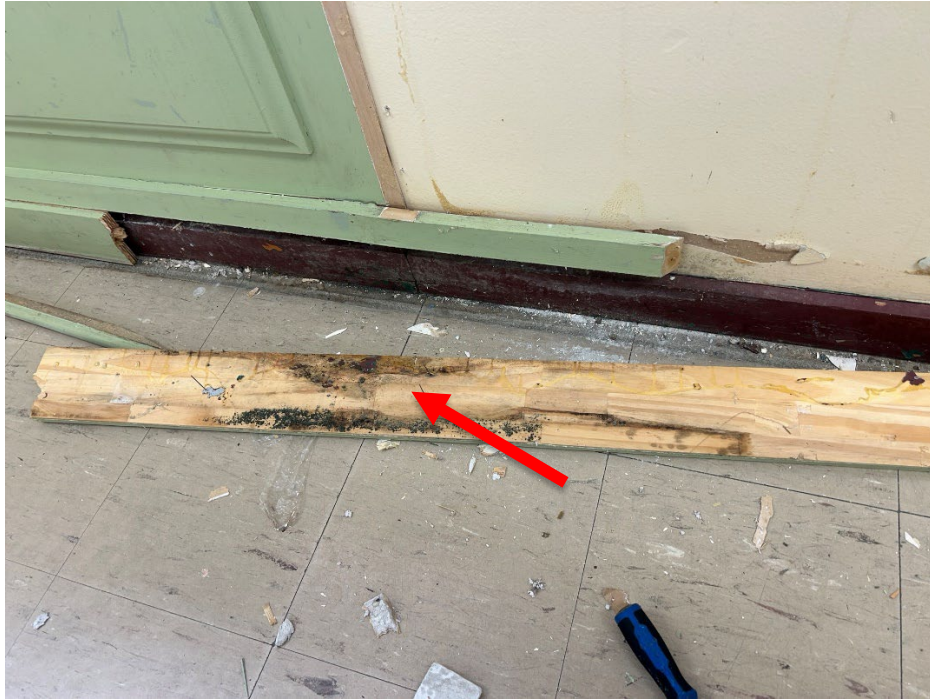
**Photo 13 Mould impacted wooden baseboard.**

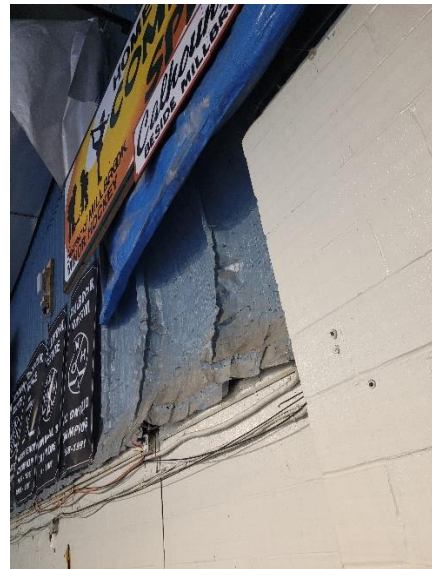
Photo 02 – Damaged Metal Siding

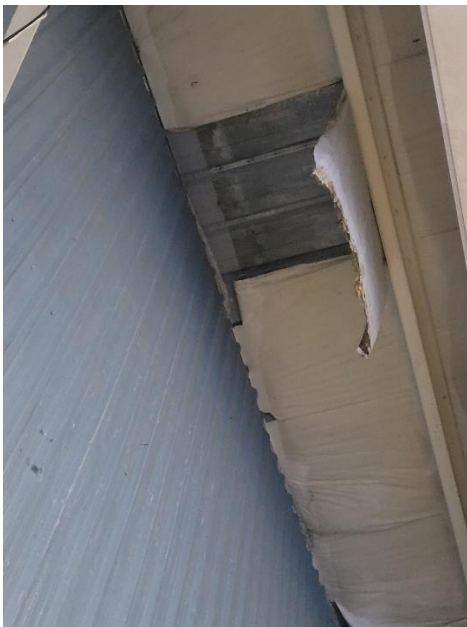
Photo 03 – Damaged Roof Insulation

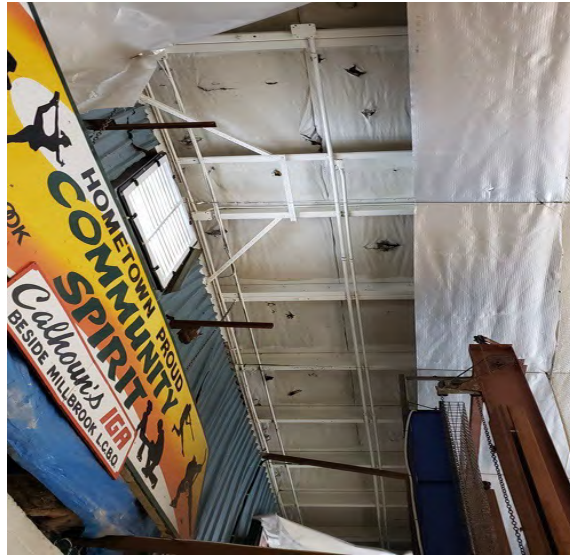
Photo 001 Hidden Roof Deck & Z-Purlins

- The roof deck generally appeared to be in fair condition with no evidence of water/moisture damage (Photo 001). However, at the area exposed behind the net, there were visible minor damage due to puck impacts. For aesthetics purposes, we recommend that the damaged areas are cleaned and painted as required to match original conditions.
- The cold formed steel z-purlins was generally observed to be in fair to good condition.

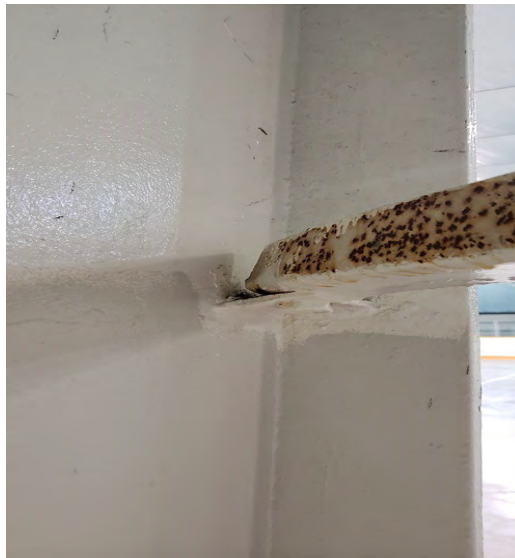
- Minor localized surface rusting was observed along several bracing members (Photo 004). This is likely due to condensation and high humidity during occupancy. We recommend for the rusted area to be wire brushed clean to bare metal and an epoxy protective coating is applied.

Photo 004      Rust on Frame Brace

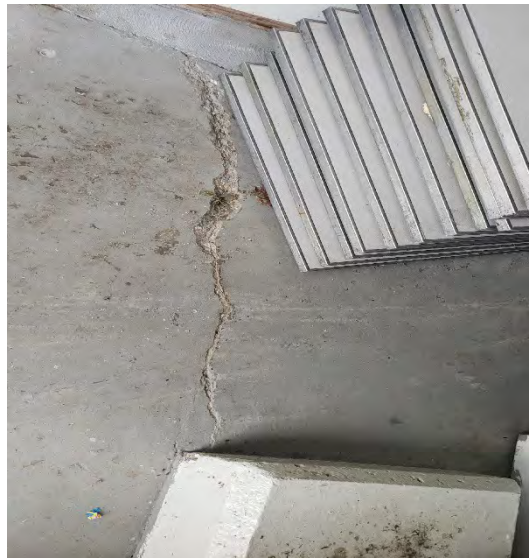
- Moderate cracking was observed near the entrance of the compressor room (Photo 017). We recommend to infill the void space with suitable mortar to match existing conditions.

Photo 017      Cracking Outside of Compressor Room

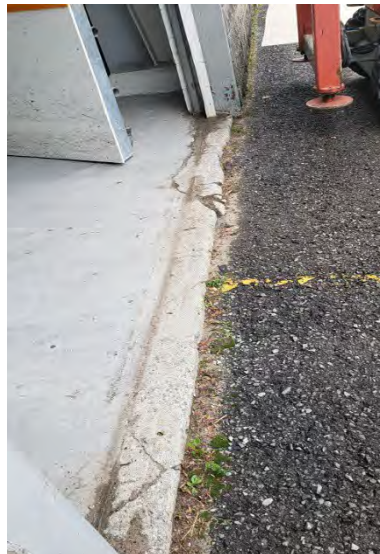
Photo 018      Apron Slab Under Garage Door

- Moderate cracking and spalling were observed underneath the exterior garage door on the East side of the building (Photo 018). We recommend for all loose and unsound concrete to be chipped out and removed and patched with a suitable repair mortar.

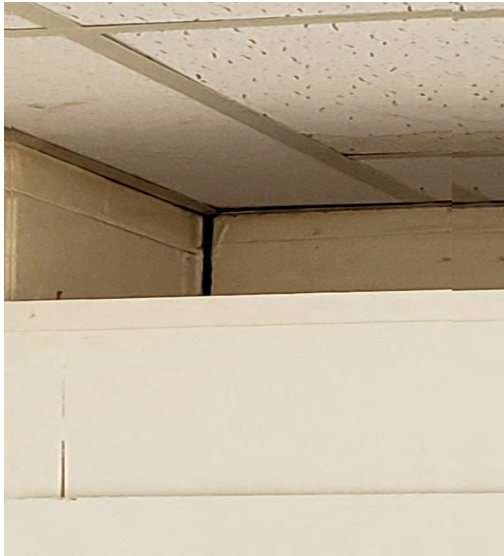
Photo 049      Wall Separation in Second-Floor Storage Room

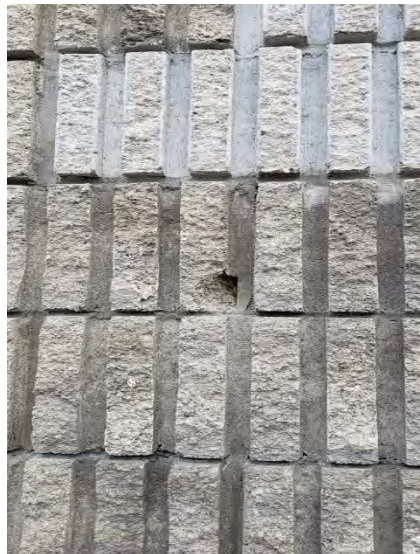
- Minor cracking of the mortar joints was observed along the architectural precast concrete wall panels at localized areas (Photo 065).
- Localized damage to single brick in the architectural precast concrete wall panels was observed (Photo 066). We recommend for the architectural precast concrete wall panels to be repaired and patched with a suitable repair mortar to prevent further deterioration of the architectural wall.

Photo 065 Architectural Block Mortar Cracks

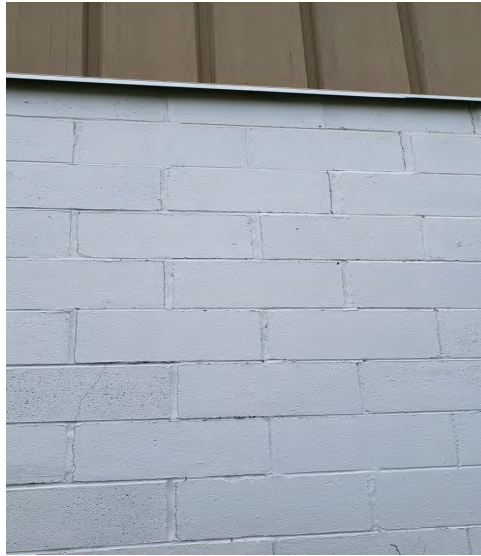
- Localized step Cracking and paint-peeling was observed along the north elevation (Photos 079, 080 and 081). We recommend for all cracked mortar joints to be routed and re-pointed to restore to original conditions. All areas of peeled paint should be cleaned, and new paint applied to match adjacent wall areas.

Photo 080      Step Cracking and Paint Peeling

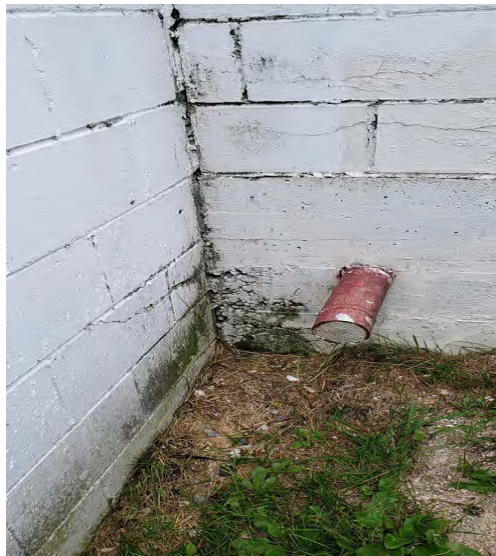
Photo 081      Step Cracking and Block Failure
