## Regular Council Meeting

| <b>Report Number:</b> | Parks and Facilities 2024-05 |
| <b>Subject:</b> | Mould Assessment Results and Required Remediation at Millbrook Arena |

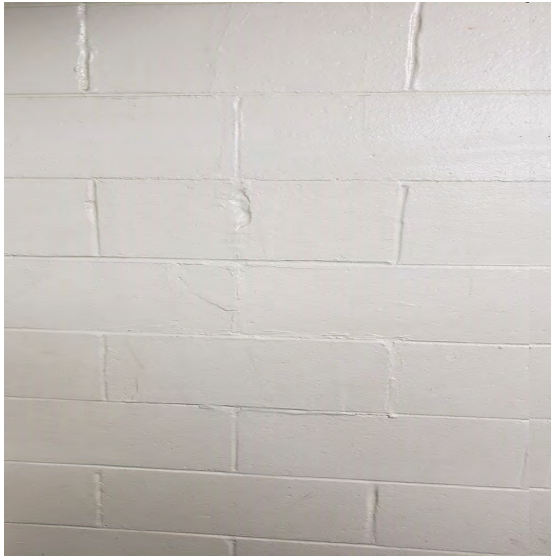
Photo 043      Localized Damage in Changeroom 3

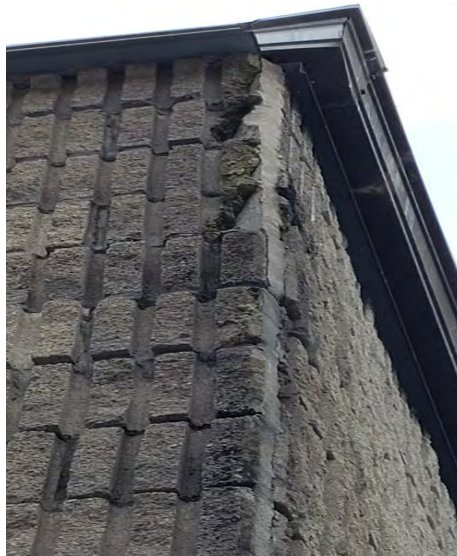
- Minor cracking of the mortar joints was observed along the architectural precast concrete wall panels at localized areas (Photo 065).
- Localized damage to single brick in the architectural precast concrete wall panels was observed (Photo 066). We recommend for the architectural precast concrete wall panels to be repaired and patched with a suitable repair mortar to prevent further deterioration of the architectural wall.

Photo 066 Localized Brick Damage

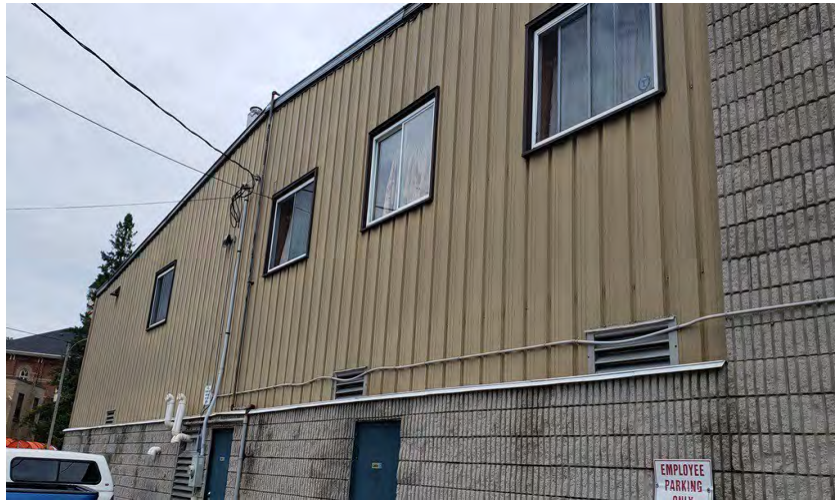
- The architectural precast concrete wall panels at the South Wall was observed to be in fair to good condition (Photo 068).
- The metal cladding above the Architectural block walls generally appeared to be in fair condition (Photo 069).

Photo 068      Architectural Precast Concrete Wall Panels

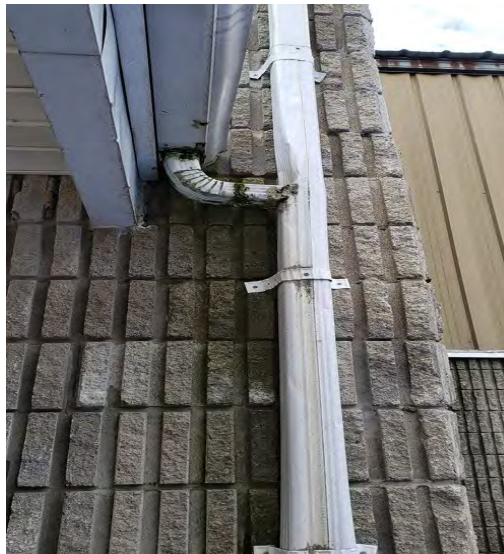
- The foundation wall near the lobby has a significant gap, and the surrounding paved area is experiences minor deterioration (Photo 071). This is likely due to the damaged eaves that is leaking water onto the wall (Photo 072). We recommend that the crack in the foundation be repointed.
- Moss was observed to be growing along the east side wall (Photo 073). This is a sign of moisture accumulation and has resulted in deterioration of the precast concrete wall panels (Photo 074). We recommend for the architectural precast concrete wall panels to be cleaned at these locations and to prevent further more advanced damage to the wall system.

Photo 071      Gap in Foundation Wall

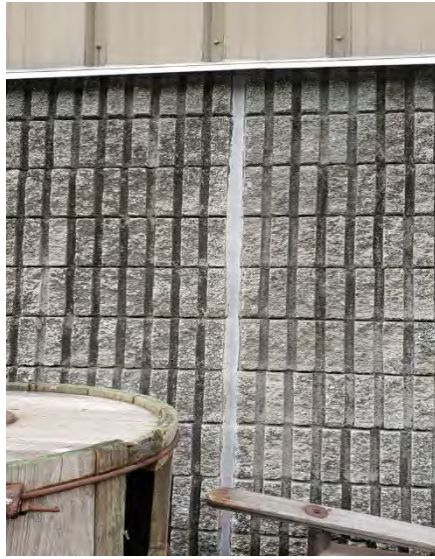
Photo 074      Deterioration of Blocks

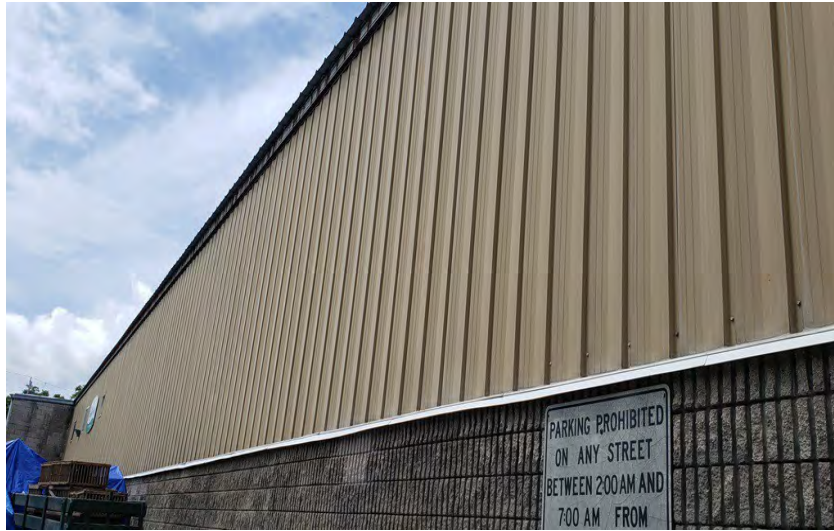
- Caulked panel joints along architectural precast concrete wall panels appear to be in good condition (Photo 075).
- Metal cladding above architectural precast concrete wall panels appears to be in good condition (Photo 076).
- Minor damage to the metal was observed above the garage door opening near the North side (Photo 077). A section of the steel lintel enclosed by the metal was visible at the damaged location and the lintel was observed to be in poor condition with significant rust accumulation and loss of cross-sectional area (Photo 078). We recommend that this lintel be exposed, removed and replaced with a new lintel to match existing conditions, and the damaged metal siding be repaired/replaced to restore to original conditions. to match the surrounding area.

Photo 075      Wall Joint

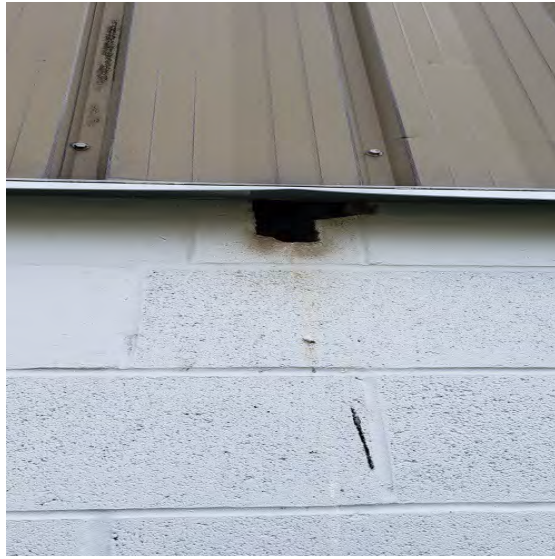
Photo 092      Localized Foundation Wall Damage

- Localized deterioration at the top of the foundation wall behind a rainwater leader location was observed (Photo 092). We recommend that this area be fixed with suitable repair mortar to ensure no further damage can be done to the structure.

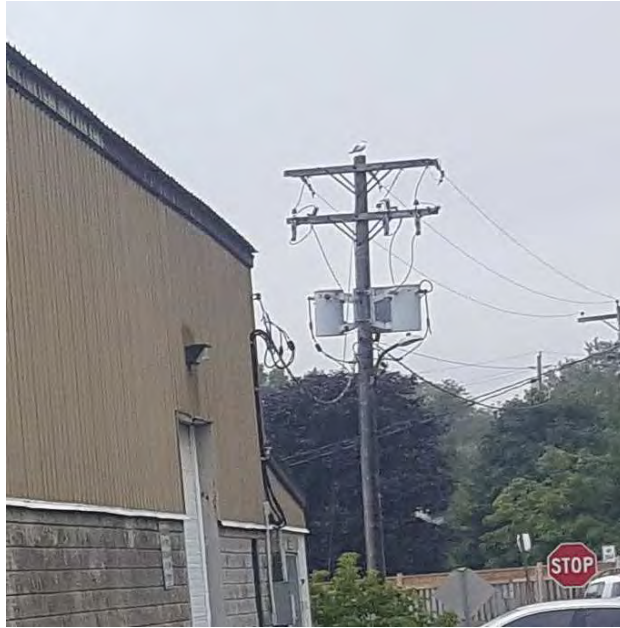
- 2.1 The facility is powered by two separate utility services. The 120/240V 200A service that supplies the front of the building (Front Service) and the 600V/347V 400A service that supplies the rear of the building and ice plant (Rear Service).
- 2.2 A set of three pole mounted 75kVA pole mounted transformers supply the Rear Service used primarily for the ice plant. The transformers are configured as a solidly grounded 4 wire 347/600V supply at 225kVA.
  - 2.2.1 The transformers and pole assembly appear in decent condition.
  - 2.2.2 The secondary conductors run overhead individually from the service pole to the arena wall where they transition to core flex and run down the exterior wall and into the rear electrical area and the 600V main disconnect.

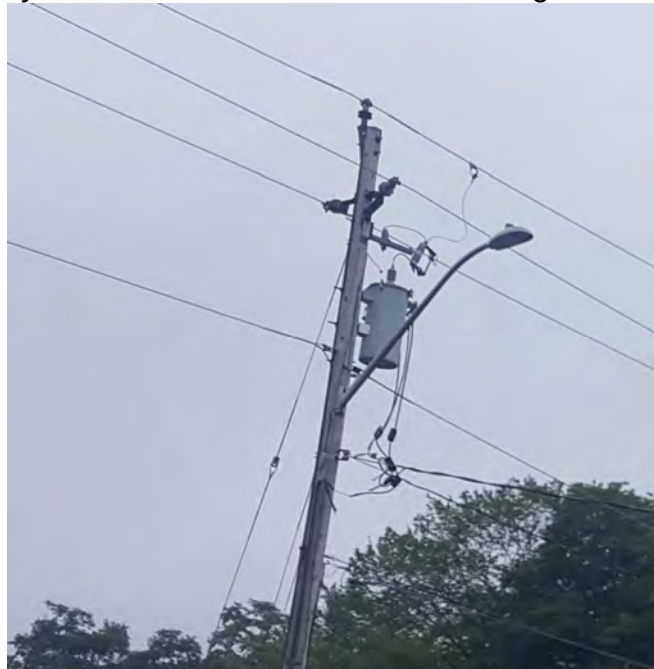
- 2.3 A single pole mounted 50kVA pole mounted transformers supply the Front Service used to supply front of the building, including hall, canteen changerooms and washrooms.
- 2.3.1 The transformer appears in good condition. The transformer also supplies the street lighting to the west.
- 2.3.2 The secondary conductors run overhead individually from the service pole to a wall mounted cable termination rack. The cables enter a raceway via a weather-head and drop to the utility meter on the exterior of the building.

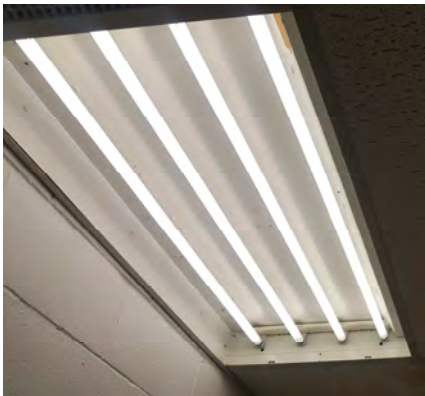
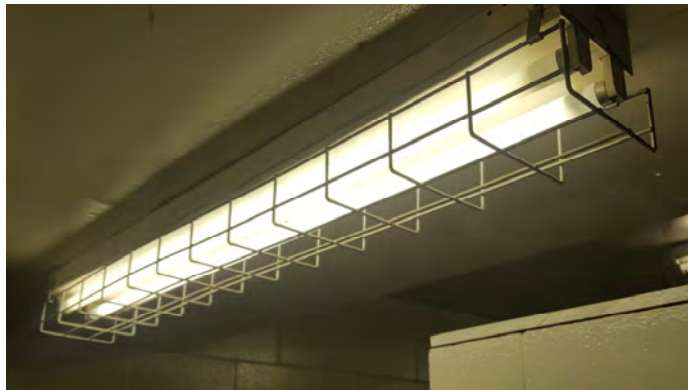
5.3 Most of the existing 120V lighting fixtures are tubular florescent fixtures. Some incandescent fixtures have been upgraded to CFL lamps.

5.4 It is recommended to replace the existing fluorescent fixtures with LED, not just replace the lamps with LED equivalents.

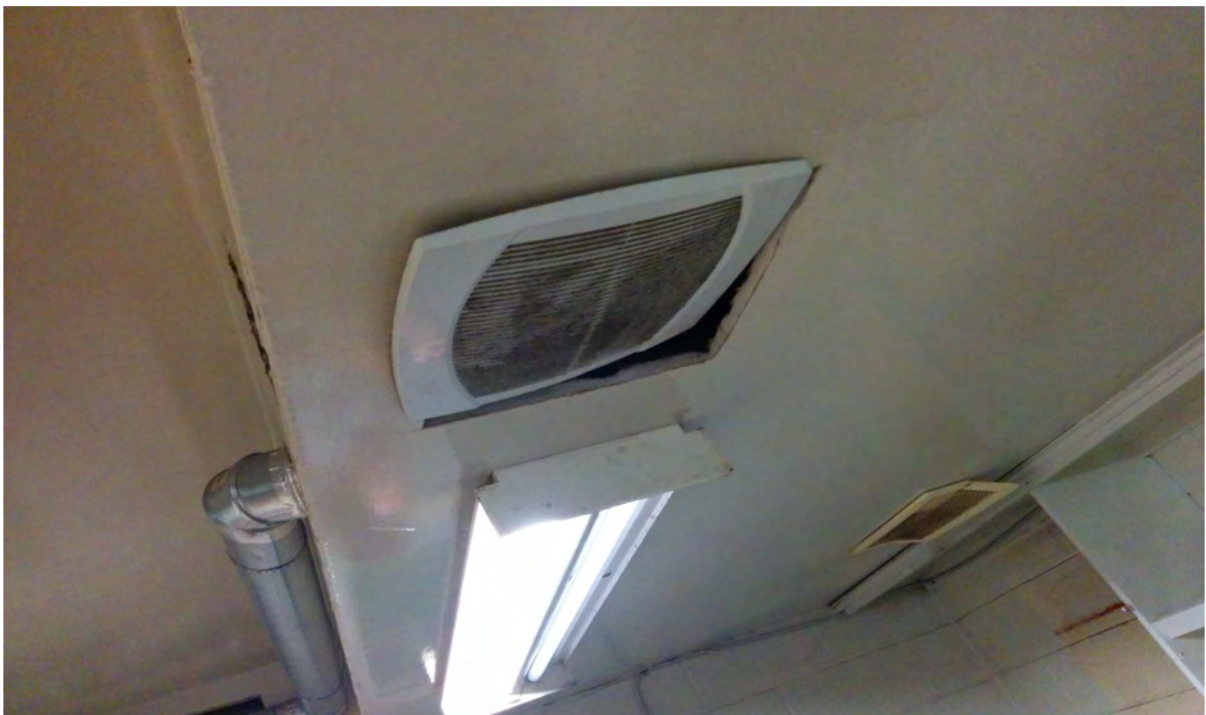
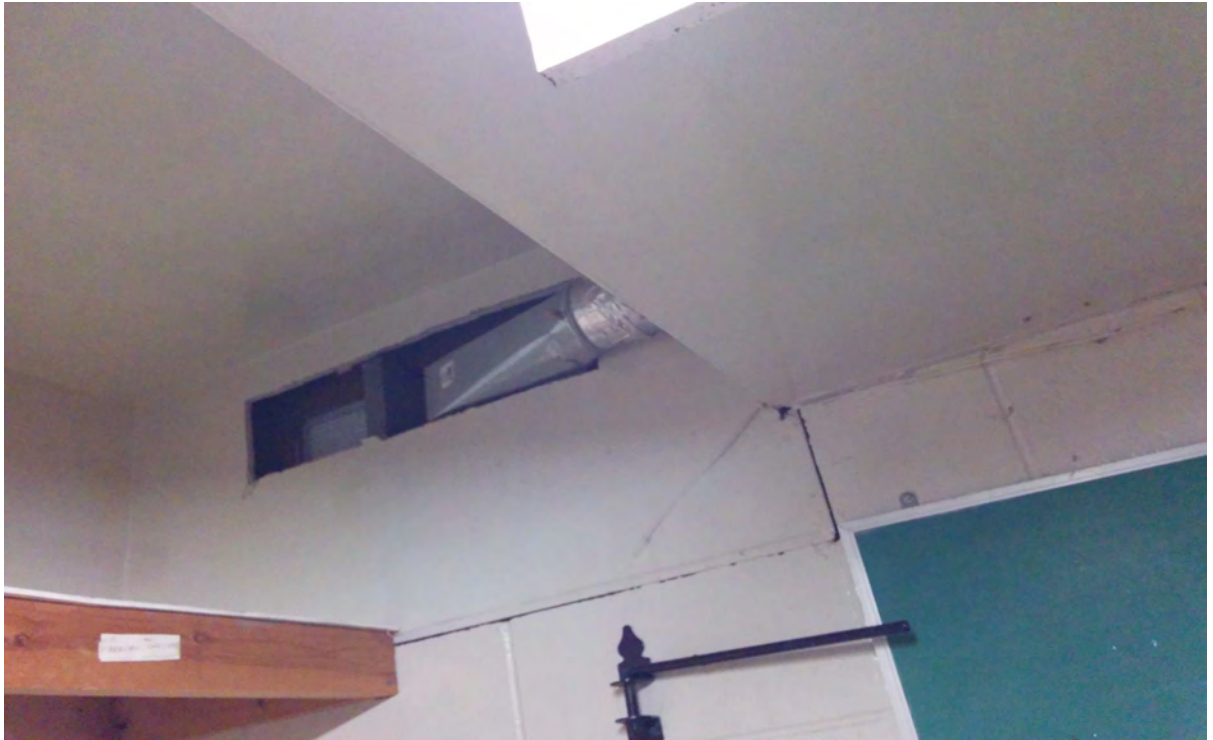
- 2.8 The supply diffusers were in a space and the return grills were in a different space.
- 2.9 Some other spaces had no supply diffusers nor return grills.
- 2.10 There is no heating, ventilation and cooling in the rink lobby as required by codes and standards. The whole corridor in the first floor had no diffusers or grills, which means no heating, cooling or ventilation.
